**CASE STUDY**  
 Works: Demolition  
 Sector: Regeneration scheme

## Carlton Street Multi-Storey Car Park, Swindon

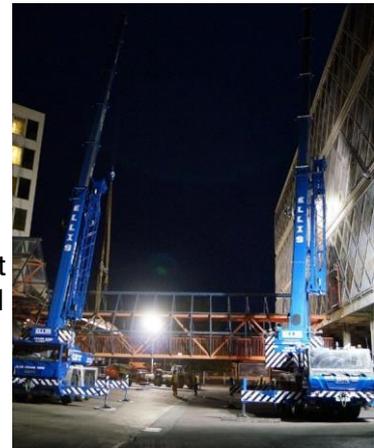
**SOLUTION:** The bridge was removed under a contracted lift which required two cranes to lift and lower the 36-tonne bridge to ground level. After the successful removal of the footbridge,

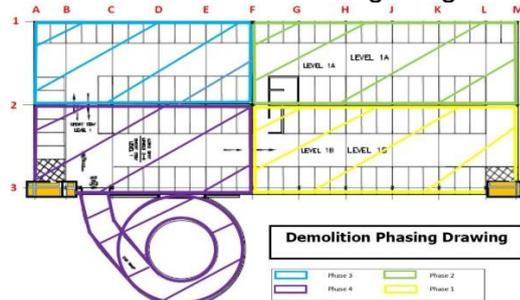
Lawson Group utilised the use of a crane to remove the steel beams, which each weighed three tonnes, from the top floors of the car park.

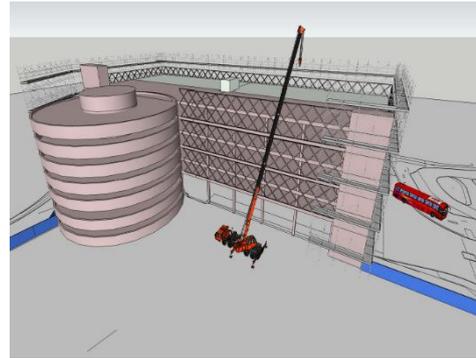
All of the demolition work undertaken by Lawson Group was carried out in accordance with the NFDC High Reach Guidance, bay by bay in a methodical manner ensuring that the structural integrity of the building was maintained. The sequence within the methodology entailed the external lattice to be removed and lowered to the ground. The Crane was used to lower the pre-cut beams.

This process was utilised multiple times to ensure that the entire sixth floor steel work frame was removed.

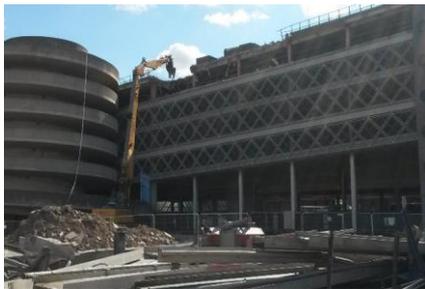
The location of this project was a heavily pedestrianised area; therefore, Lawson Group undertook this work at night so that the crane had the access to complete this work. The complexity of this project required Lawson Group's specialist equipment including a reach excavator, specialist demolition skid steer and remote controlled Brokk.

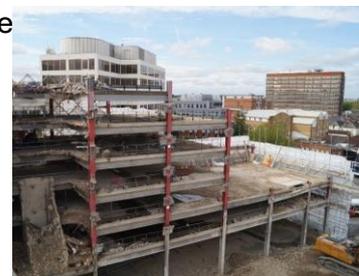
Lawson Group entered into the third phase of demolition by working through the grid lines 1-2 A-F, again starting on the fifth floor working progressively down to the first floor.

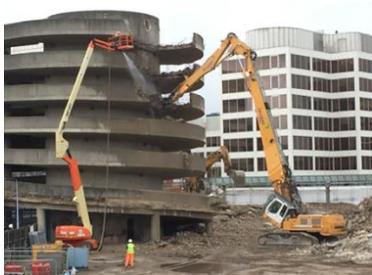
The demolition of Carlton Street car park was a four phased plan, with the final phase of the demolition requiring the removal of grid lines 2-3 A-F starting on the fifth floor working progressively down to the first floor and included the removal of the staircase and lift located in the South East corner. Within the final phase of demolition, the spiral ramp was also demolished, utilising the high reach excavator starting at the top and working down. Further consideration was given to works dust suppression, a dust boss water dampening system was utilised and targeted water spraying from height. Furthermore, dust and noise monitoring was completed throughout the works.
