**CASE STUDY**

Works: Demolition

## Ilford Rail Depot, London

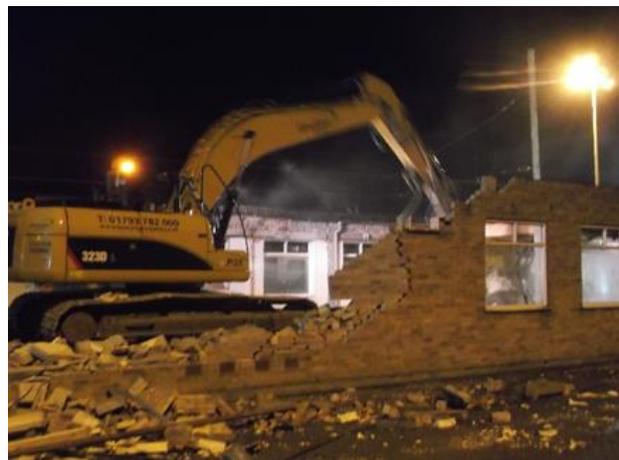
A 360-degree excavator with mechanical shear attachment was used to commence deconstruction of the paint shop from the west elevation working in an easterly direction. It was deconstructed bay by bay. The excavator first cut at roof level to the west gable exposing the roof trusses. These were then cut, allowing one bay at a time of the roof to be lowered in a controlled manner.

The paint shop was the largest unit to be demolished. The structure comprised of insulated steel cladding on roof purlins that span the rafter of the 177m long building. The internal fittings, including the air tight spray booth, were removed by Lawson Group's strip out team prior to the deconstruction of the
