CASE STUDY

Works: Asbestos removal and demolition

Royal United Hospital, Bath

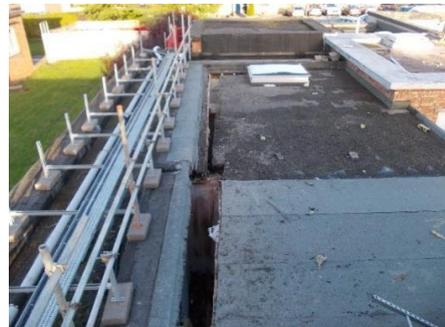
In order to make sure the oxygen pipes were protected and not affected by the works, temporary scaffold protection was installed. Double layer scaffold board surrounded the pipes and ply board was applied to the top of scaffolding. Monoflex was used on the scaffolding to protect the environment, public, patients and staff from dust, noise and debris.

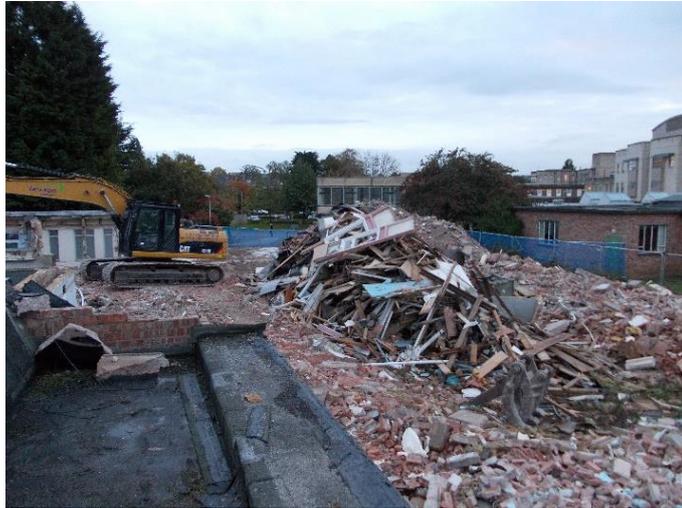
Two excavators were used onsite to complete the demolition of a hospital wing which included firstly soft stripping the internal areas of the building and the structures. During this process, waste materials were segregated for recycling purposes and removed. The methodology included the removal of the building in its entirety along with the removal of ground floor slabs, excavation of foundations and removal of hard standings.
