Summerstown, London

OVERVIEW: The works comprised of the demolition of a light industrial building along with the removal of slab, foundation, hardstanding and asbestos. The site was located to the west of Summerstown and to the east of the former Wimbledon Football Club stadium.

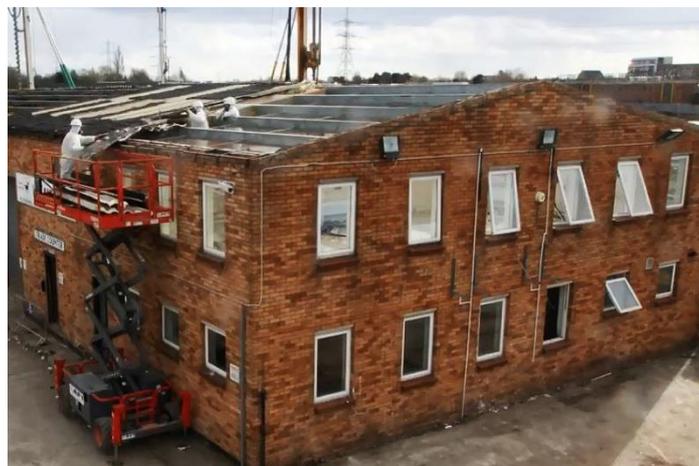
To remove the non-licensed asbestos roofing sheets from the building, access towers were used inside the building with MEWPs outside - each with a team of highly qualified operatives.

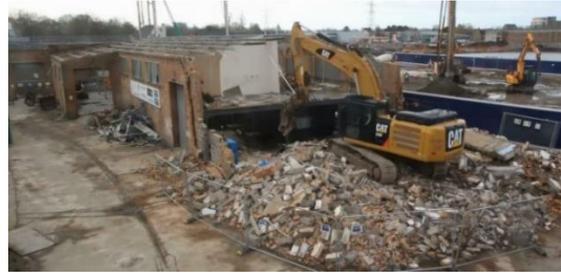
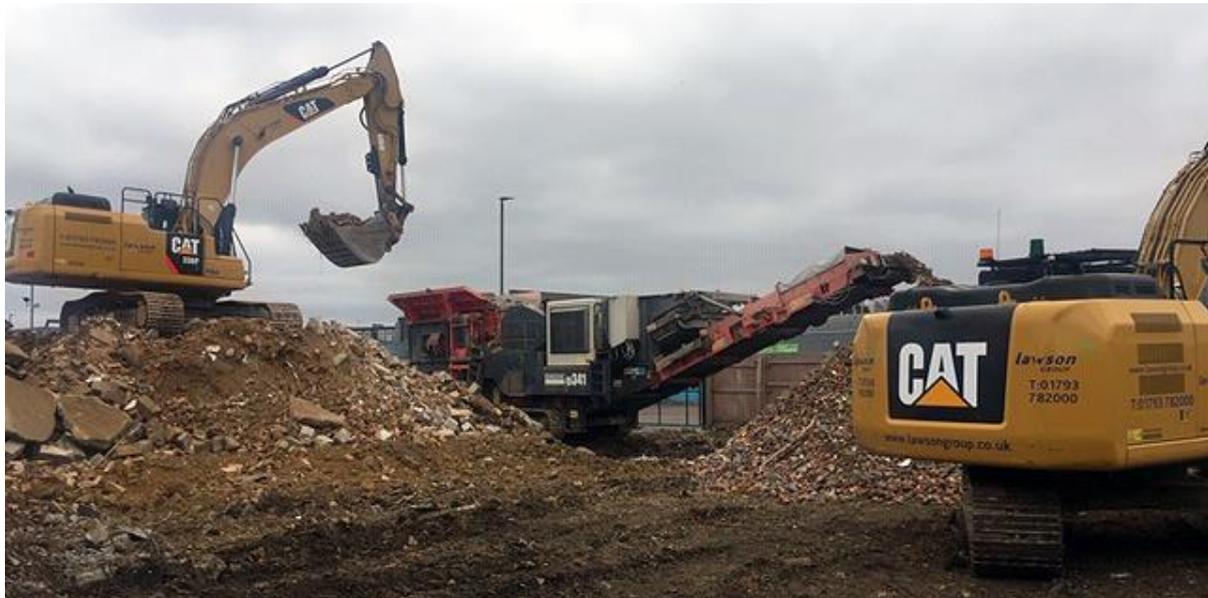
The methodology stated that demolition started on the section of building nearest the site entrance and to work its way to the rear of the site. To undertake this phase of the project, Lawson Group used one of its own 360 excavators with a demolition attachment. Following the deconstruction of the brick-built buildings, work started on removing the floor slab and foundation. When stockpiles of concrete and brick had been generated, a second excavator with breaker attachment proceeded to break up the concrete into pieces of no bigger than 500cm². A mobile crusher was positioned next to the stockpile of material on firm level ground. These concrete pieces were then passed through a mobile crusher that was operated in accordance with the safe operating procedure from the NFDC.
