CASE STUDY

Works: Licensed
Asbestos removal
and Demolition

Former Bus Depot, Muller Road, Bristol

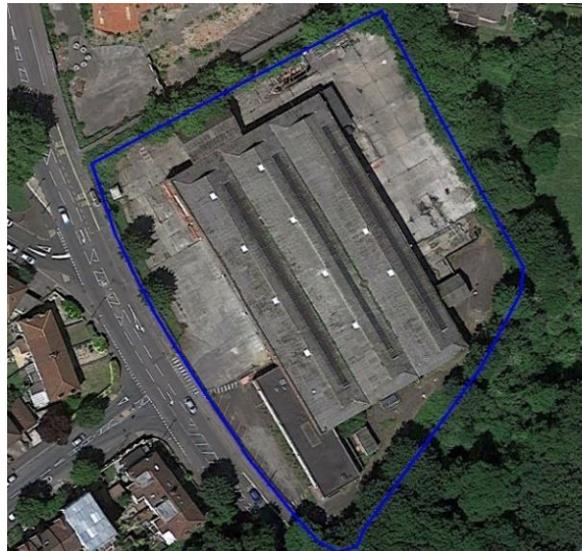
The main structure comprised of a large open space with several inspection pits, several smaller internal rooms were located to the rear of the building. The roof was formed with three pitched sections comprising of a steel frame enclosed with cement bonded roof sheets.

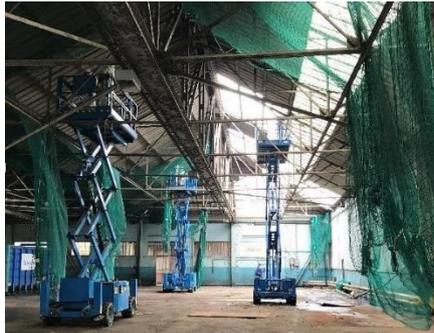
SOLUTION: The buildings were first stripped of any loose furnishings and fixtures. Next, Notifiable Non-Licensed Work (NNLW) commenced for the removal of the CBA roof sheets. Cat B trained Demolition Operatives worked within Mobile Elevated Working Platforms

(MEWPs) to remove the sheets. Three MEWPs were in operation with a pair of operatives assigned to each one, all operatives were IPAF and CAT B trained. MEWPs were logistically positioned for the safe removal of CBA sheets. All sheets were first dampened using a suppressant mix, the bolts were cut and sheets lowered one by one. They were then removed using a skid steer and placed in a stacked pile into an enclosed 40-yard skip. During the CBA

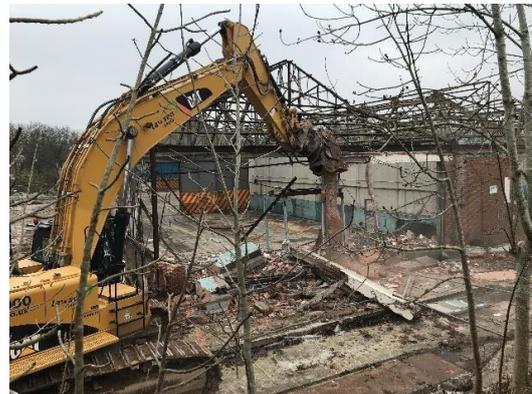
Once all CBA sheets had been removed, a 360 excavator with a hydraulic shear attachment was used to cut the steel frame of the roof. A second excavator was used to process and load the steel into 40-yard skips.

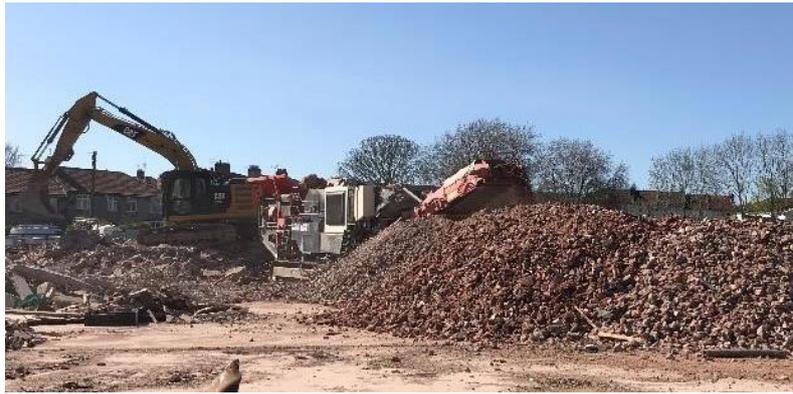
Once all slab, foundations and underground obstructions were removed, all the concrete and hard-core were processed on site with company owned mobile processing equipment. This produced 6F2 crushed stone material suitable for reuse within the future residential development.
