OVERVIEW: Lawson Group undertook the demolition and soft strip project of a former Travis Perkins site in Cheltenham.

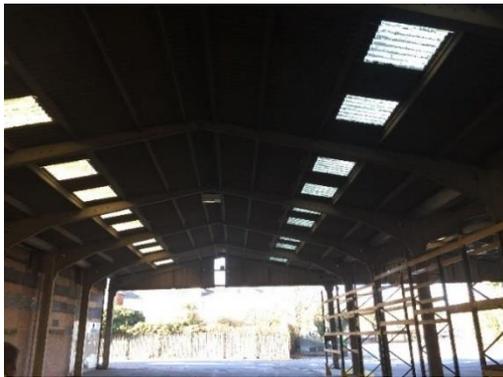
Loose contents from within the structure, including furniture, appliances, loose waste etc. were removed by hand in a controlled manner and arising's managed in accordance with the Site Waste Management Plan. Door frames and skirting boards were removed by using bar and sledgehammers and all nails and fixings were removed from the walls. Once this was done and the Asbestos sheeting had been removed from the roof by fully qualified operatives, then the demolition and dismantling of the structures could start.

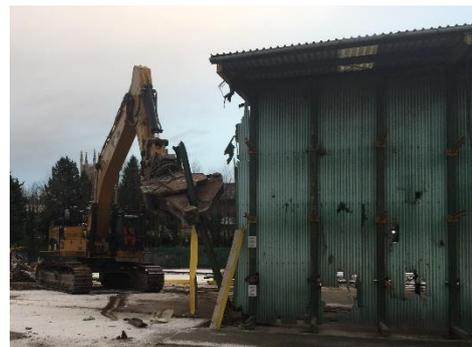
Using the hydraulic sheer attachment, the roof purling's were cut back to the next supporting roof beam allowing.

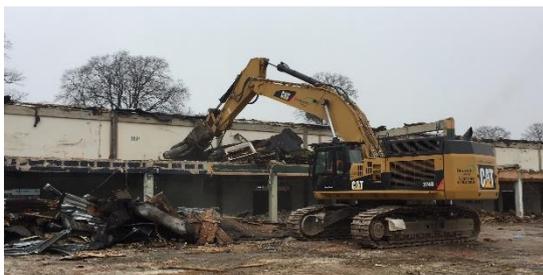
The demolition excavator then removed the concrete frame, generated from the above process, and stockpiled away from the working area. Each piece of steel and concrete was thoroughly inspected for any remaining asbestos cement.

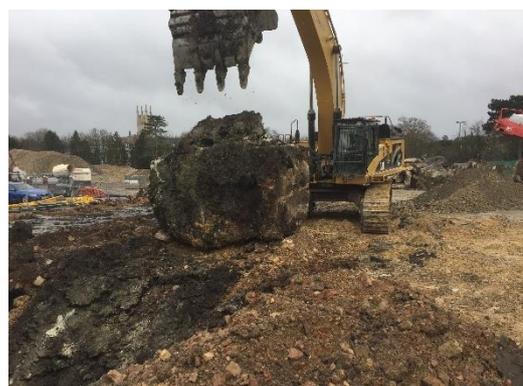
Starting at the edge of the buildings slab, the excavator with bucket attachment lifted the slab in large pieces, ensuring the ground below was not disturbed. Once the slab had been lifted, the

excavator returned to the edge of the slab and dug around the first foundation.

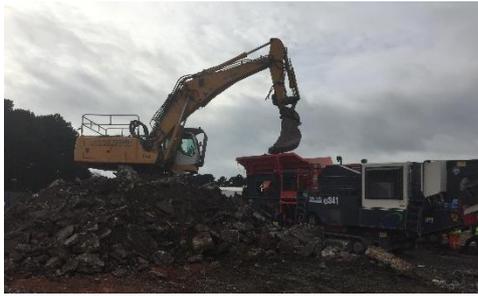
The foundation was lifted out and stockpiled ready for breaking. The area of ground from where the foundation had been removed was then back filled and tracked in. This process was repeated until all foundations had been removed. Once a stockpile of concrete had been generated, a second excavator with breaker attachment then proceeded to break the concrete into pieces no bigger than 500cm². The Mobile Crusher was operated in accordance with the Safe

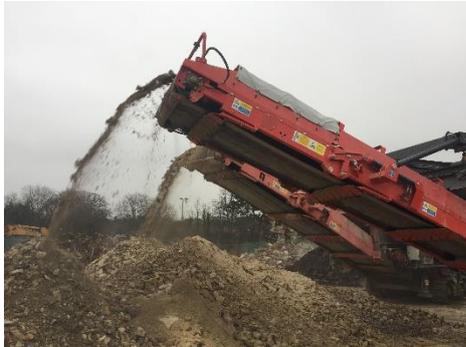
Arisings were crushed to 6F2 graded concrete, loaded into a dump truck and taken to the working area. The dump truck tipped each load and the excavator spread the 6F2 out to a depth of 300mm

thick across the required area.

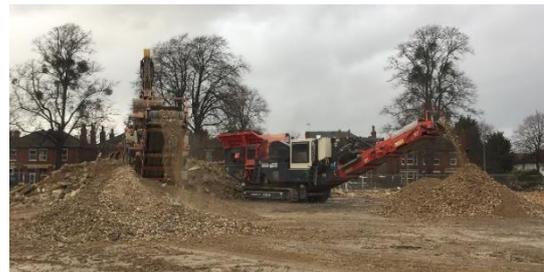
Once the area had been spread with 6F2, the excavator tracked over it to lightly compact the area.
