CASE STUDY

Works: Hand Demolition
and Soft Stripping

Sector: Office Regeneration

Westgate, Bristol

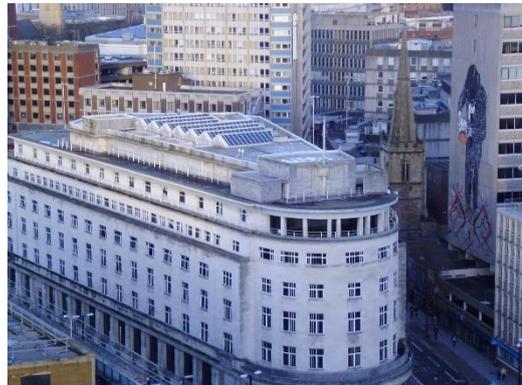
Solely structural demolition took place to enlarge the central atrium that was currently there. The Brokk machine was used for this procedure to enable a balcony to line the outskirts of the atrium with flats leading off this walkway. During this procedure, strict health and safety rules were adhered to by all following the Working at Height Regulations 2005. This enabled the operators of the Brokks to produce their work successfully and safely when undertaking the necessary work close to the edge of the floors. The operators of the machines wore harnesses and the correct PPE for the job.
