CASE STUDY

Works: Demolition and Party Wall Separation

## St Peters Hall, Hinton Road, Bournemouth

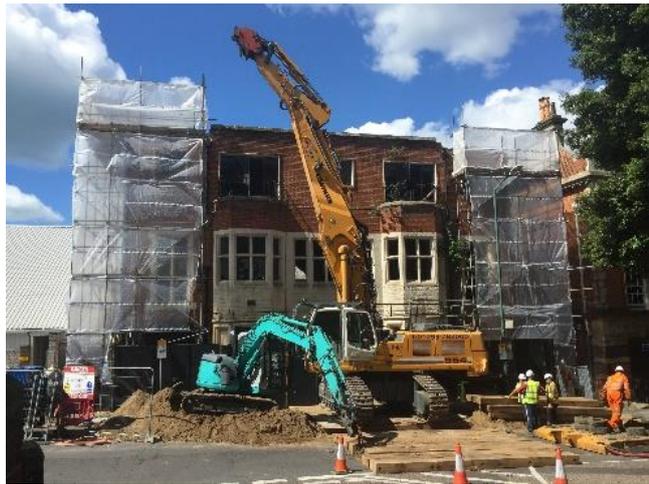
Road protection consisting of layer of sand and 150mm thick hardwood mats were placed over the road to protect the surface from any damage during the works. Scaffolding was erected to the rear and both side elevations of the building, this was reduced as the building progressively became lower throughout demolition.

Due to the close proximity of neighbouring properties the gable end was removed by hand. Access scaffolding was erected to the side and fitted with handrails and Monoflex. Drop zones were created inside the building to prevent debris spreading.

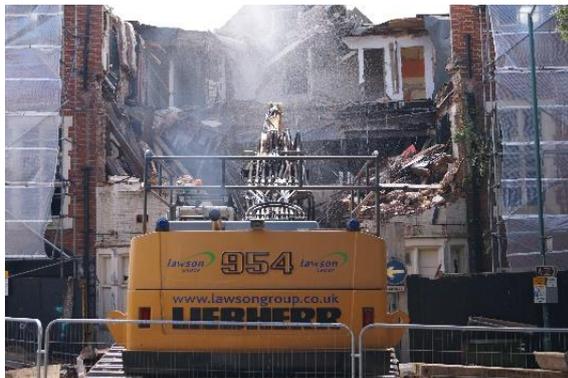
Mechanical demolition commenced from the front elevation using a high-reach excavator. A hydraulic grab attachment was used to demolish the front wall of the top floor. The surrounding external walls were then removed. Starting at the front of the building, the walls were reduced in height allowing the brickwork to fall into the drop zone.
