CASE STUDY

Works: Demolition

Sector: Regeneration Scheme

17 London Road, Staines

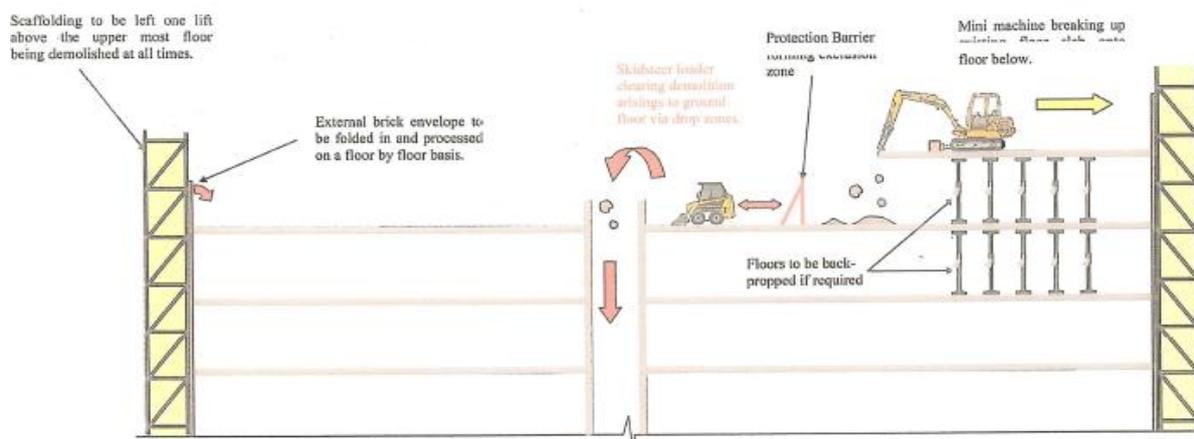
Section showing the use of mini machines for the demolition of the mid level office block progressing on a floor by floor basis with all debris being transported to ground floor level by drop zones within the existing lift shafts.

Encapsulated façade scaffold to exposed elevations.

Existing structure (columns to lower floors omitted for clarity).

The east wing was dismantled using the floor by floor method up to but excluding the central core. A full height access and protection scaffold had been erected to all elevations and incorporated two scaffold fans over London Road.

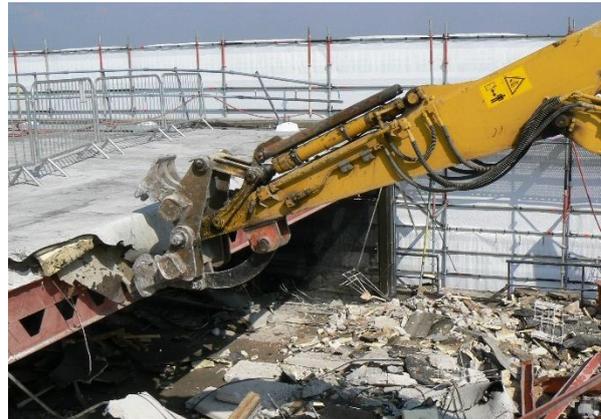
During the on-site establishment phase, trial holes were broken out in the upper floor slabs of the building to investigate floor spans and construction. The existing drawings and any existing trial hole information was used in conjunction with these findings. Load testing was carried out and the permissible floor loadings ascertained. Machine sizes and any necessary back propping requirements could then be determined.

In addition, the condition of the structure and construction techniques were investigated to provide as much information prior to demolition commencing.

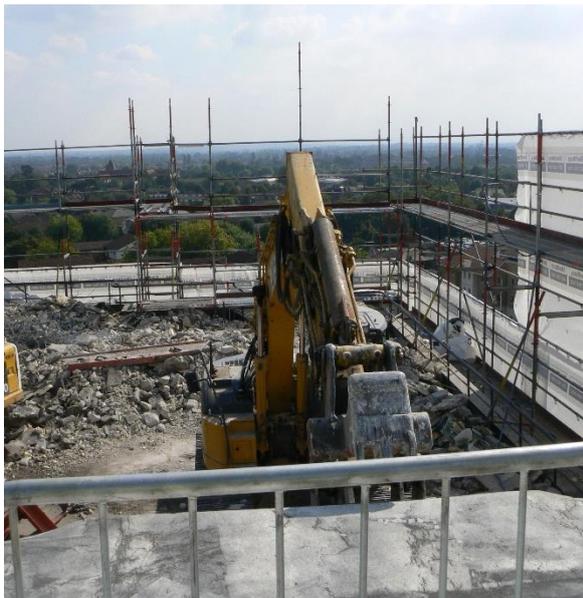
The floors were deemed to have sufficient loading capacity, without any additional propping from below, to allow a 13T 360D excavator to be positioned and operate within a structural bay. This was however confirmed again during the on-site establishment phase and the maximum permissible machine size ascertained. However, if it was later found that back propping was required, then it was carried out prior to the machines being lifted to that floor.

This progressive small machine demolition involved the use of up to 13-tonne excavators, equipped with either pneumatic pulverisers or breakers which undertook progressive small machine demolition. Due to weight restrictions, only one machine could be used in any one bay, at any given time (a bay being a floor area usually between four existing columns).

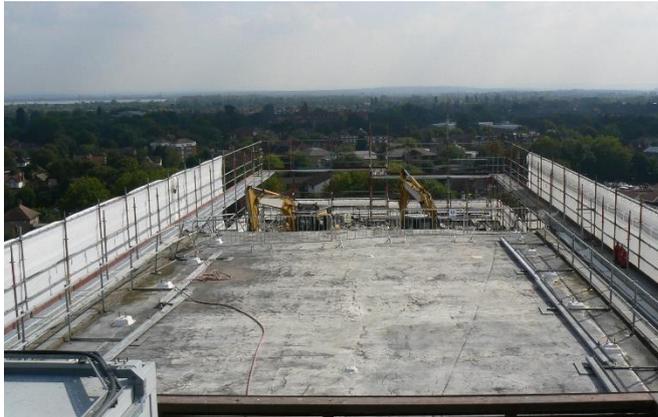
The existing roof to the east wing was constructed of precast concrete planks supported on Metsec beams. When the scaffold was completed to this level, it was necessary to break open

the roof slab by handheld breakers to allow the demolition plant to be lowered to the 9th floor slab.

Only with the above activities completed or in place could demolition work commence of the existing structure. To facilitate demolition of the structure, up to 13T 360° excavators and 3 tonne bobcats were lifted to roof level and onto the 9th floor slab using a mobile crane.

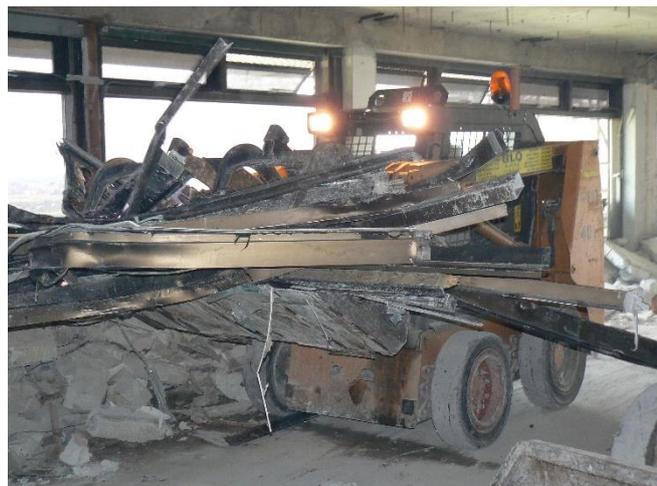
It was ensured that only one 360° excavator was in any one bay at any one time, the superstructure was demolished onto the floor level below by using the 360° excavator fitted with a hydraulic pulveriser attachment.

Marks were painted on the floor slab to indicate to each machine operator of the permitted track locations. These were given by the structural engineer as 1.5m from the centre of the columns on the North elevation and 1m from the centre of columns on the south elevation.

Each operator was inducted specifically to his or her tasks and instructed to remove the keys when leaving the machine to prevent unauthorised use. The debris was processed and separated to increase the efficiency of its removal from site and the bobcat then collected and transported the debris to the drop zone. Some of the debris was used to form a ramp to the floor below to allow the plant to transfer between floors. Once on the floor below, the excavator pulverised the slab of the floor above down onto the level on which he was standing, and the process was repeated down through the building

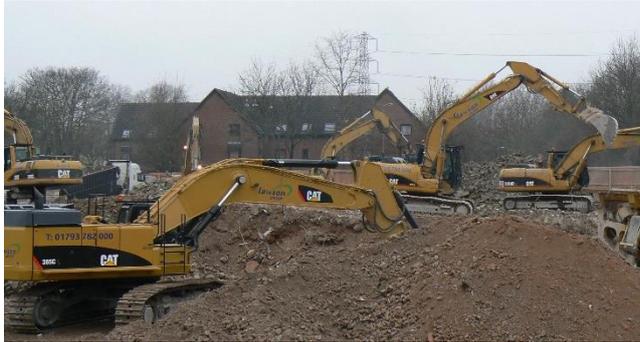
Immediately upon reaching the new level, the demolition arisings were loaded away via the drop zone at the earliest opportunity to reduce the imposed loading on the slab This operation was executed in a controlled manner, ensuring that no single item of demolition was excessive in size or weight. At ground level, the materials were removed by excavator and or loading

shovels and taken to the crusher for processing. The process was repeated on a floor by floor basis until the east wing was cleared to the top of the ground floor slab.

The remainder of ground floor slab was broken onto the basement slab. Walls and columns in the basement were then reduced to 150mm above the existing adjacent ground bearing slabs. Plant working in the basements were provided with a minimum 600mm mat of demolition debris or crushed concrete laid over the slab as protection.
