CASE STUDY

Works: Demolition & Asbestos Removal

Broomhill House & Guildford House, Bristol

OVERVIEW: Lawson Group were awarded the demolition and asbestos removal project at Broomhill House and Guildford House in Bristol.

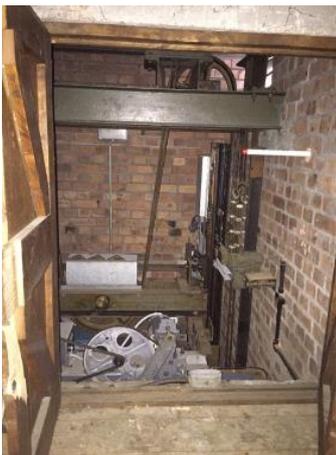
A CAT scan for live services was undertaken before work starts. Before any demolition works could commence, licensed asbestos containing materials had to be removed under controlled conditions from Broomhill House first. This project included the removal of 28m² of AIB, 240LM of AIB Soffits, 30m² of AIB Debris and 210m² of Asbestos lagging residue inside the boiler room. Locations of the AIB included areas such as the lift shaft, boiler room, main kitchen and external soffits.

The soffit removal works were undertaken in accordance with Asbestos Liaison Group Memo 03/12 - The removal of external soffits. Lawson Environmental (part of Lawson Group) utilised subcontracted scaffolders for safe access and egress. All Licensed asbestos was removed under controlled

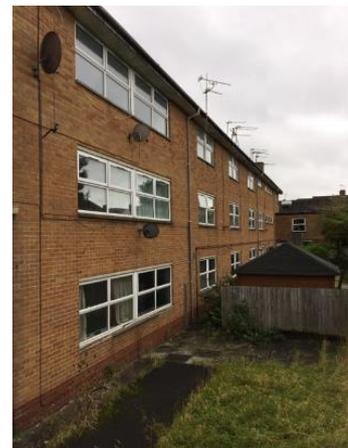
Scaffold was erected along the gable end of the building; this was to protect trees that had a preservation order on them. Dust suppression equipment was set up next to the demolition excavator with a water supply from a fire hydrant. All entrances to each building were securely fenced off to ensure no entry could be gained to the building.

There was a drop zone and respirator zone set up around the building using Heras fencing with signage attached. All voids in the ground, such as manholes and sewers, were protected.

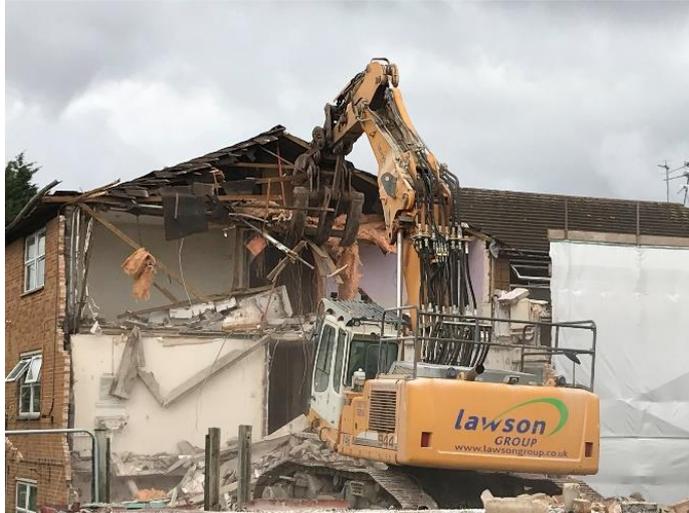
A 360° demolition excavator, with demolition attachment, was positioned at the rear of the structure.

Using a hydraulic grab attachment, the roof was removed back to the first supporting column allowing one bay of the roof to be lowered carefully to the ground floor slab. The wood and timber sections were then removed and lowered to ground level, away from the building and were later processed and loaded into the designated forty-yard waste bins. Once the roof had been removed, the internal walls and floors were removed and lowered to ground level.

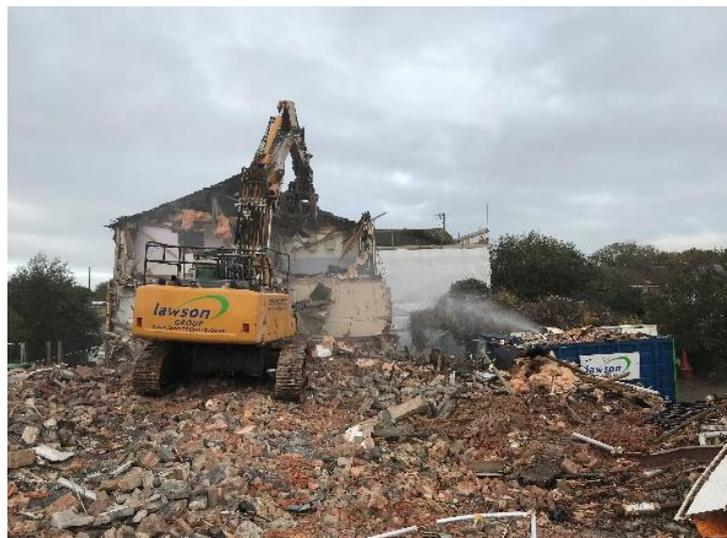
Once a stockpile of concrete had been generated, a second excavator with breaker attachment then proceeded to break the concrete into pieces of no bigger than 500cm² ready for crushing. The Mobile Crusher was operated in accordance with the Safe Operating Procedure from the NFDC.

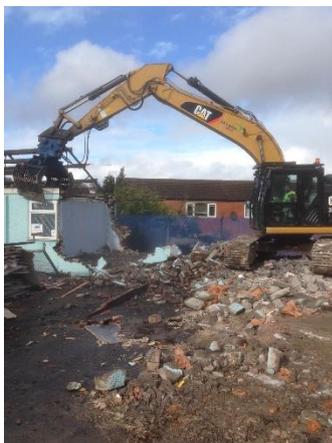
A respirator only exclusion zone was set up, utilising Heras type fencing with warning signage attached to prevent unauthorised access into the working area. A scaffold tower was set up inside the building under the first section of roof that had to be removed, this was checked by the supervisor.

Two operatives accessed the underside of the roof sheets, using a killer sprayer, the sheets were wetted first. Using bolt croppers, the bolt heads were cut from the underside of each fixing point into the purling support. They then carefully lowered each roof sheet to ground level; operatives then placed the sheets into a forty-yard asbestos bin for removal from site. This process was then repeated until all the asbestos cement roof sheets had been removed. This was carried out under the watchful eye of an ecologist to check for the presence of bats - none were found.

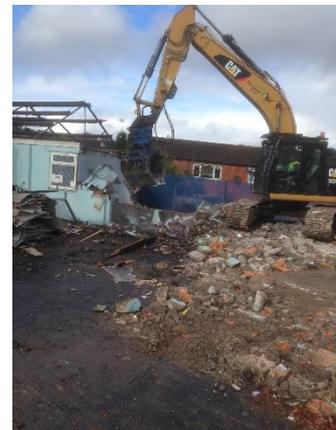
Once the roof had been safely removed the deconstruction and crushing of the building could begin. This was carried out using a similar method to that described above for Broomhill House.
