CASE STUDY

Works: Soft Stripping
& Cladding Removal

Brunel Centre, Swindon

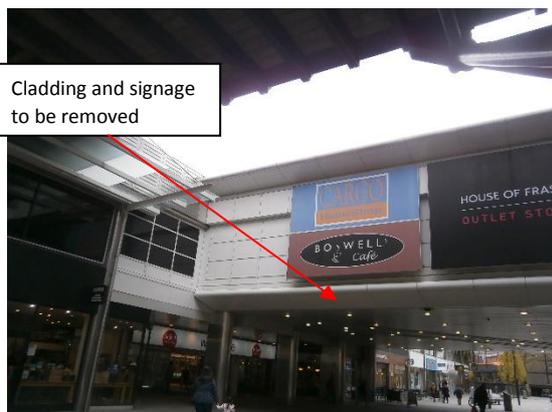
Cladding and signage to be removed

The site supervisor and banksman were located at ground level in the working area for the duration of the work. A scissor lift was utilised for access to the top of the cladding, vegetation and sign. Using a battery powered impact drill, the screws were removed. As each panel was unscrewed, a second operative supported each panel, once it is

free from the building it was lowered to ground level in the MEWP. This process was repeated until both sides of cladding had been removed.

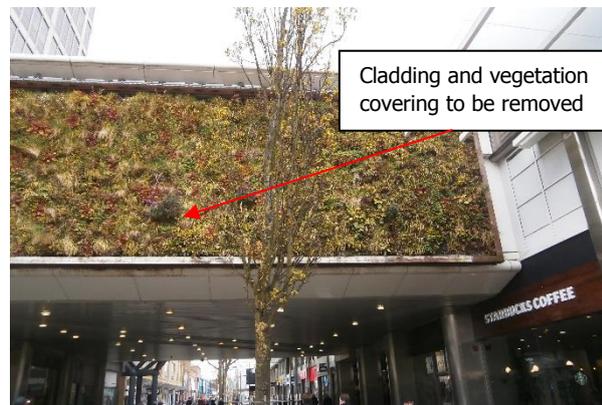
Cladding and vegetation covering to be removed

cladding and vegetation feature, this was removed out of working hours as agreed with the Brunel Centre management beforehand.

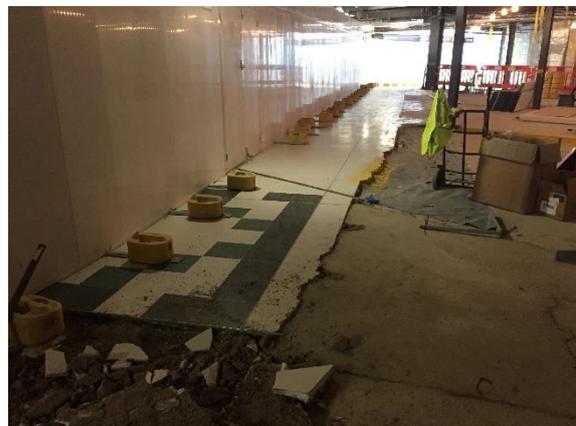
across. Using floor scrapers, the floor tiles were quietly lifted. As each section was removed, they were loaded into a wheelbarrow and removed via the goods lift.

A handheld water sprayer was used to ensure any dust generated was kept to a minimum. Once the floor tiles had been removed the area was inspected to see if it could be opened to the public. All trip hazards were removed, and a temporary floor covering was put in place.
