CASE STUDY

Works: Demolition

Redwell Towers, near M25

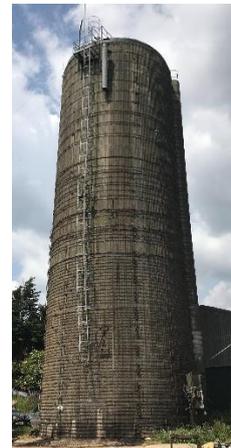
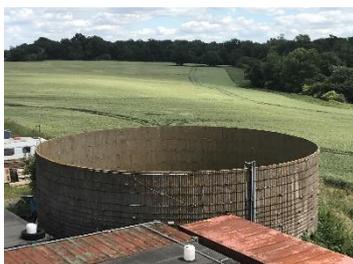
Silo One - A twenty-metre-high silo with a metal roof, containing rotted, wet straw that filled the silo to 8.5 metres in depth.

Silo Two - Six metres in height and was empty apart from rainwater to a depth of approximately 1 metre.

Both silos were constructed of the same material - pre-cast panels with post tensioned hoop bars fixed externally.

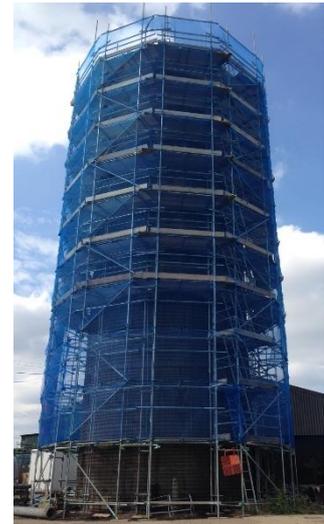
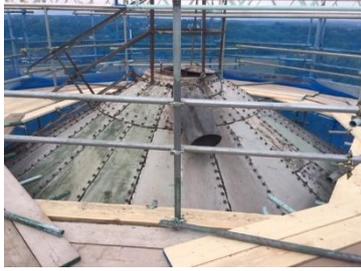
SOLUTION: Once Heras fencing and welfare had been put in place, the scaffolding was erected around silo one. A trained scaffolder, following a separate method statement, built a circle independent tower around the silo. This also had debris netting to keep all material within the scaffolding and site.

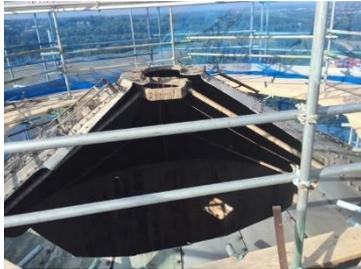
Once the scaffolding had been erected, one of Lawson Group's highly trained demolition supervisors assessed the scaffolding up to the top of the silo. Once confident that the scaffolding met Lawson Group's high standards, cutting of the metal roof could begin. Using a disc cutter, sections were cut out and allowed to fall, in a controlled manner, into the pre-determined drop zone within the silo.

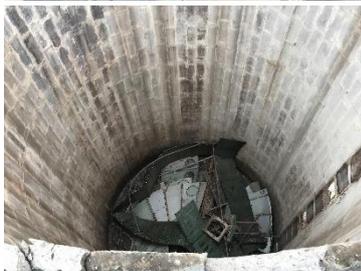
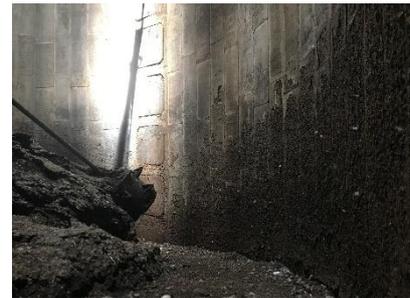
Following an engineer's report, a small drone was used to inspect the inside of the silo, an engineer was asked to check the integrity of the structure before any structural demolition took place. Once the engineer gave the all clear to proceed, Lawson Group's demolition operatives began to hand demolish the concrete sections from the top down. Working from the scaffold tower, they were removing no more than one section all around the top at any time. Operatives used TE1000 and TE750 breakers which

were run from a generator located on the ground. As operatives broke out each section of concrete wall, the sections were lifted out and deposited down a rubble chute positioned on the scaffold - this allowed the material to be removed from site efficiently.

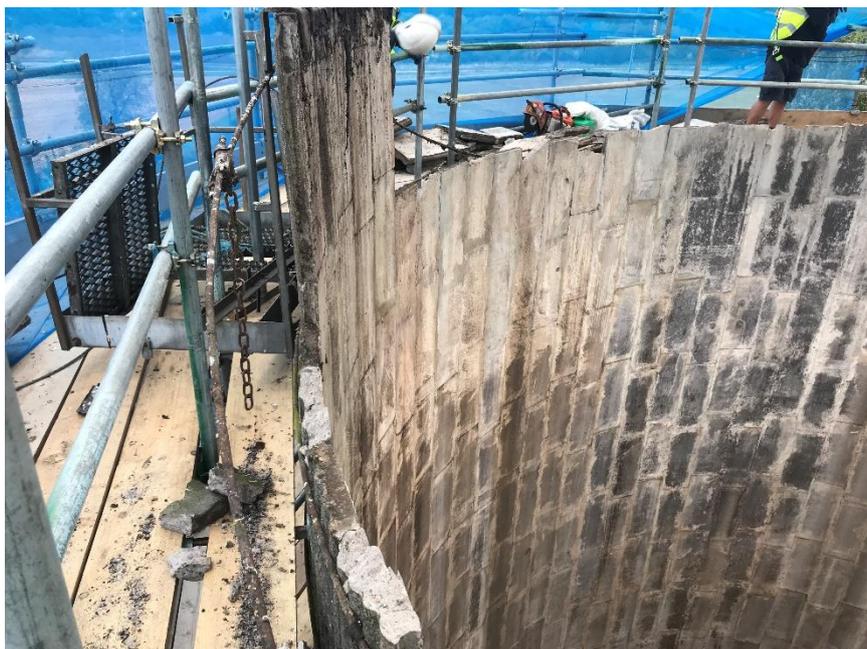
Once the first section of wall panes had been removed, a disc cutter was used to cut the external stress bar, this was cut into one-metre sections and placed in the rubble chute for removal from the working area. Prior to cutting, it was ensured that no residual prestress remained in the bars and only loose non-stressed bars were to be cut. This continued down the silo, working around the top of the silo, one metre at a time.

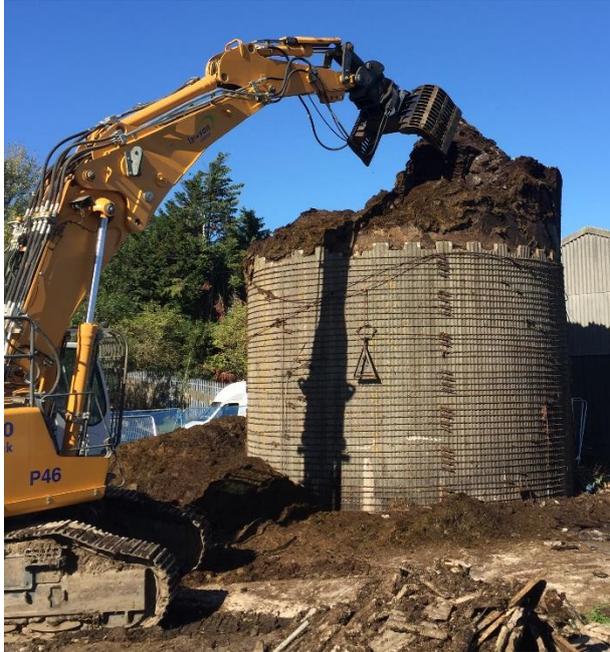
Due to the rotted and wet straw located inside the silo, the hand demolition process could only proceed down to approximately eight and a half metres from the ground floor. At this point the scaffold tower was carefully removed.

Once the scaffold tower had been removed, one of Lawson Group's very own Caterpillar excavators was used to remove the remaining silo structure. The machine was fitted with a re-handling grab attachment which was first used to empty the silo. A Cherry picker, with a trained operative, was brought alongside the silo to allow an operative to safely guide the excavator arm into the top of the silo. This was used purely to help the high reach machine see from an elevated level and help guide the arm to grab

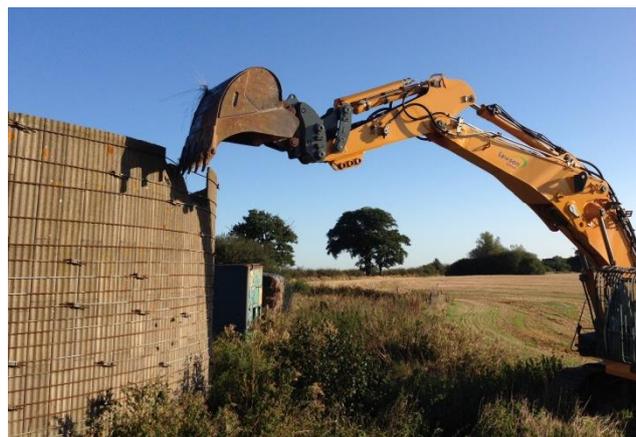
Once silo one had been completely removed, demolition works could begin on the smaller silo two, using a demolition excavator. The machine was fitted with a suitable attachment working from the top down, the machine slowly demolished the structure. The structure material, once on the ground, was processed and left on site. Like the first silo, all steel bands surrounding the structure were cut and loaded into the 40-yard skip and taken off site.

RESULT: Both silos were successfully removed and, where possible, any materials were recycled onsite.
