## Various Royal Mail Strip Out Projects

**OVERVIEW:** Lawson Group have successfully completed strip out works for various Royal Mail buildings around the UK, the projects were completed in partnership with the main contractor. This case study concentrates on four of the many locations: Southampton, Eastleigh, Greenford and Jubilee Hounslow.

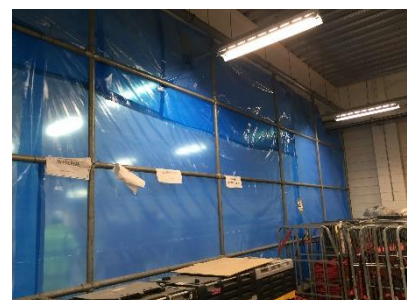
The work was located in the Southampton Royal Mail Sorting Office and consisted of the removal of the internal PSL offices, located in the main sorting area of the building. The Royal Mail depot was used 24 hours a day and had to remain in use during the works. A planned timeframe was agreed to take place over one week.

Due to the location of the offices a dust screen was erected around the structure using scaffolding with monarflex attached. The soft strip and demolition of the office was carried out by using hand tools, all waste generated was carried out of the designated doors and deposited into a 40-yard bin located on the loading dock.

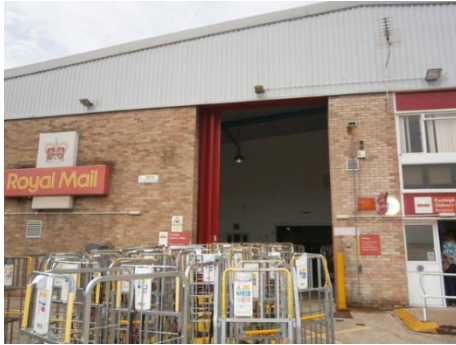
The work was located in the Eastleigh Royal Mail Sorting Office and consisted of the removal of two large plasterboard walls in the main sorting areas. There was also a soft strip of the male and female toilets needed, located in the office on the ground floor and the soft strip of the canteen area on the first floor.

This Royal Mail depot was also in use 24 hours a day and would have to remain in use during the works. Dust protection was required to ensure the live working areas did not get contaminated with dust or any arisings from the works.

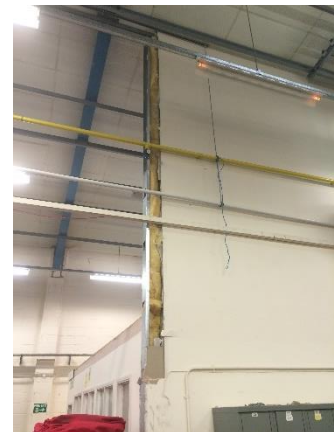
A Refurbishment & Demolition Asbestos Survey for all structures had been carried out. This showed that there were several areas of asbestos that were to remain in place and not to be disturbed. These were marked on the site plans and indicated to all site staff during the site induction. However, some of the asbestos had to be removed including:

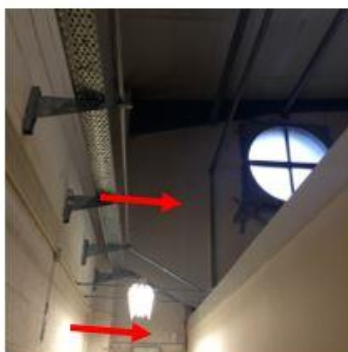
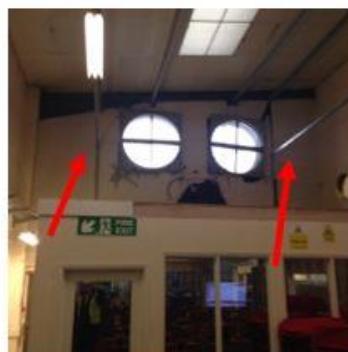
- Removal of asbestos containing Artex & plaster board ceilings cut out 6no approximately 400x400 holes in the Artex asbestos ceiling to the office and 2 other adjacent rooms
- Removal of approx. 20m<sup>2</sup> of Asbestos Insulation Board (AIB) indicated by the red arrows below:

The perimeter of the site was fully enclosed with Heras type fencing and asbestos removal signs displayed to form a respirator zone to enclose asbestos removal works.

Removal of asbestos was under fully controlled conditions to include enclosures and negative air pressure all as current CAR Regulations 2012. A DCU was set up and operational, enclosures were formed. DCU, airlocks and baglocks were positioned as per the agreed site

plan. Pre-formed asbestos removal enclosures were smoke tested prior to becoming operational. Personal air monitoring was carried out during removal works and following removal works a four-stage air clearance test.

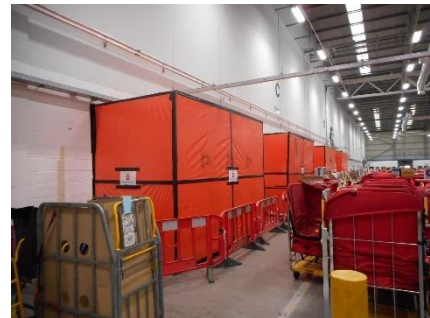
The door to be removed was indicated by the Site Manager. Two materials lifts were positioned at each end of the door (the safe working load of each lift was 300kg). Once in place, access was gained via a scaffold tower where the roller was unbolted using hand tools.

Once free from its mounting brackets, the roller was lowered down to ground level and removed from site and placed in the designated waste bin. All mounting brackets were unbolted from the wall and removed from site also.

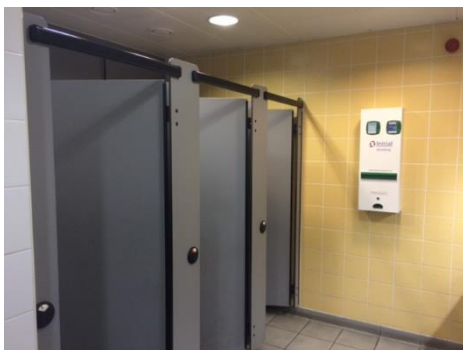
The work was located in the Jubilee Royal Mail Sorting Office and consisted of a strip out of male and female toilets along with the removal of a high-level wall and turnstiles, located in a safe area of the sorting office.

After services had been made safe, work could begin on the toilets. Loose contents from within each male and female toilets were removed. All partition panels sink units and all sanitary ware were removed first. Using a floor tile remover, the floor coverings were then lifted and removed from the rooms. Operatives then removed the
