**OVERVIEW:** This project was part of a bigger redevelopment scheme awarded to Lawson Group. The site was made up of a former BP fuel station, car wash and shop in a busy area of Tottenham Hale, London.

**CHALLENGE:** The scope of works would include soft stripping of the premises, demolition of the superstructure, removal of waste and safe removal of underground tanks.

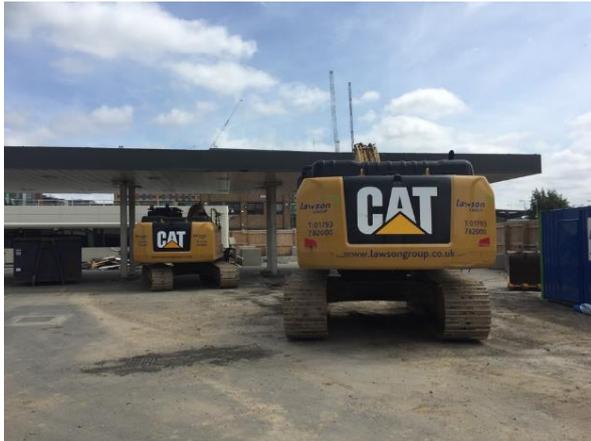
One of Lawson Group's very own 360° demolition excavators, with shear attachment, was positioned at the rear of the garage canopy. All tin sheeting was removed to ground level which in turn exposed the steel frame.

Once the steel frame had been exposed, the shear attachment was used to cut each crossbeam into one-metre sections, these were then removed from the working area. Once all the cross beams had been removed, the vertical supporting posts were cut and

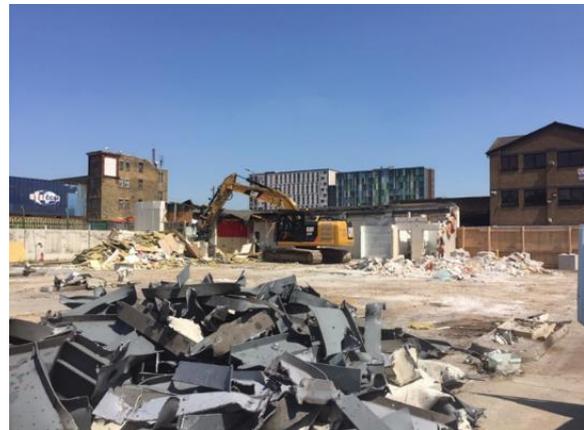
The back wall of the building constructed of brick was then next to be removed. The grab attachment was positioned over the wall and a one-metre high section of brickwork was lifted down; this was repeated. All insulated panels were lifted down in sections and placed in the processing area. Once the roof had been

removed, the side walls of the building were lifted out. The

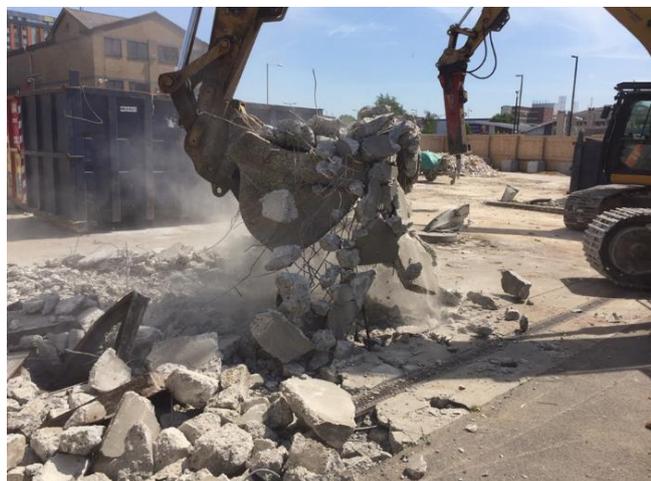
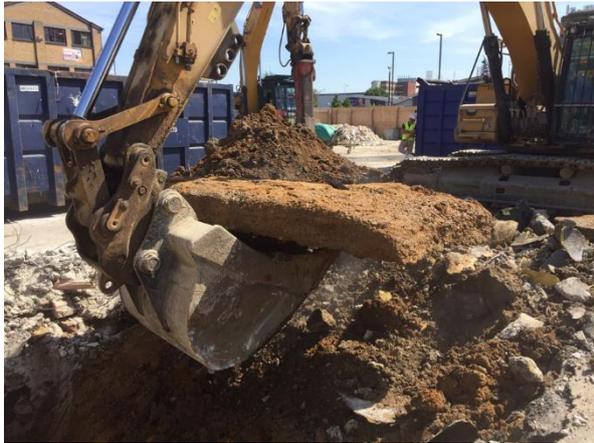
An excavator with bucket attachment dug around each interceptor, a breaker attachment was used to break out the surrounding concrete. Once the tanks and concrete had been removed, an inspection of the area was made by the supervisor. Any suspected contaminated ground was also dug out and stored on plastic sheeting. Once all the concrete had been removed, the sides of the hole were battered back, crushed material was placed in the hole and compacted in layers using a twin drum roller.

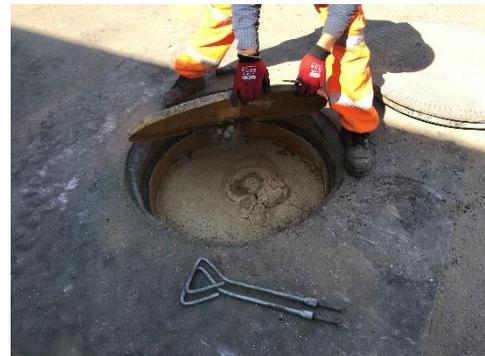
Flushing the fuel lines back to tank

Investigations showed that the fuel tanks had been filled with concrete, it was not known if the pipework to the dispensers had been cleaned, so before removal

commenced, all the pipework was pumped, washed and given a gas free certificate by the appointed contractor on site. Each tank was dug around and exposed. Using a breaker attachment, a long split was made in the top of the steel tank then a second excavator was used to pull open the top of each tank. A breaker attachment was then used to break up the concrete inside the tank. As works progressed the supervisor monitored the removal.

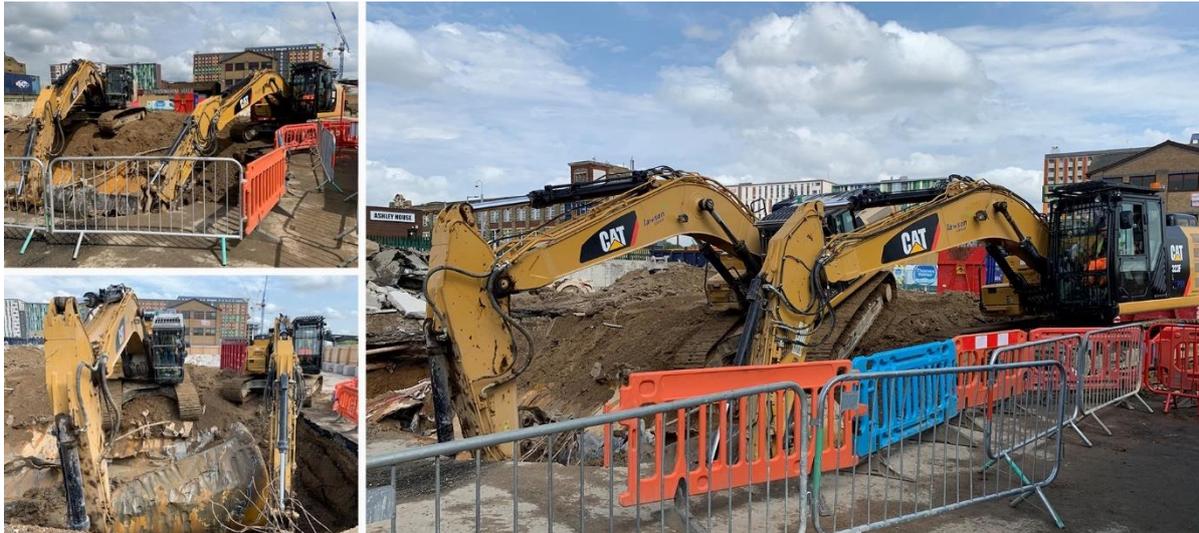
During the above processes, the site manager checked for any signs of contamination within the concrete and soil. After the tanks had been removed, the excavations were stepped back in one-metre high sections. Now all the tanks had been removed, the area was backfilled in 150mm layers using crushed material that was imported.
