CASE STUDY

Works: Soft Stripping,
Knotweed Removal and
Demolition

Arborfield Garrison Demolition of Sergeants' Mess & Buildings 69 & 69A, Berkshire

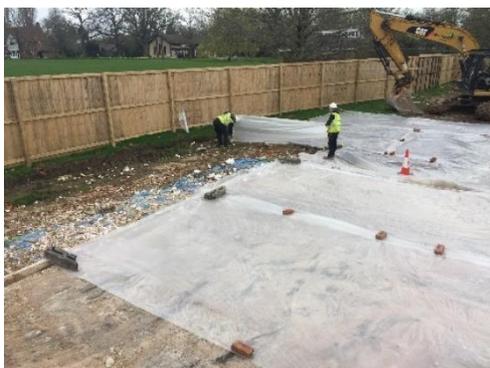
SOLUTION: As the presence of Japanese knotweed had been identified in a report, this would have to be treated first. Large areas of the ground

were covered in 1000-gauge polythene surrounding the knotweed plants. The same type of polythene was also used to line a waste skip.

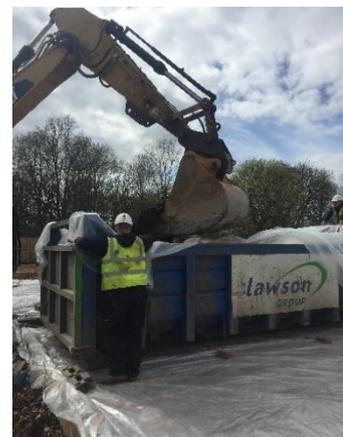
An excavator was used to carefully remove all the plants and any

potential spores lying in the soil. All waste was placed in the polythene lined skip which was sealed before removal. All plant and equipment were thoroughly decontaminated following the process. Once this had been completed, the construction of an asphalt covered car park could begin by Lawson Group's team.

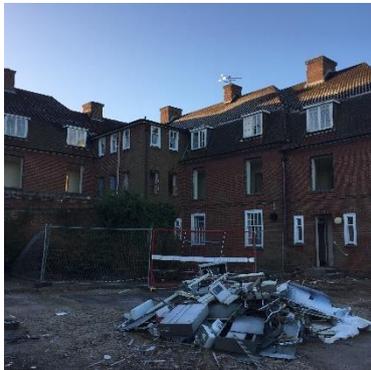
Bat boxes were installed nearby as the presence of bats near or within the structures had been identified. Lawson Group's specially trained soft stripping team started removing loose contents from within the structures, including furniture, appliances, loose waste etc. by hand in a controlled manner and arising's managed in accordance with the Site Waste Management Plan. The structure floors were cleared of general waste and debris prior to demolition.

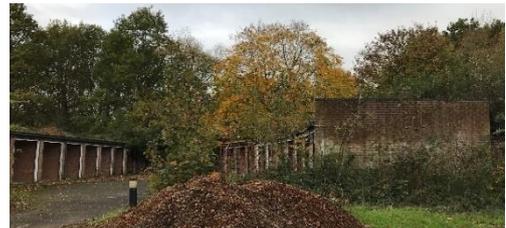
At the same time, the demolition team set about demolishing a garage block in the vicinity but nowhere near the strip out team for safety reasons. For this, Lawson Group used one of its own Cat 365 excavators with demolition attachment. Once the Soft stripping and garage demolition had been completed, then the demolition of the main superstructure could begin.

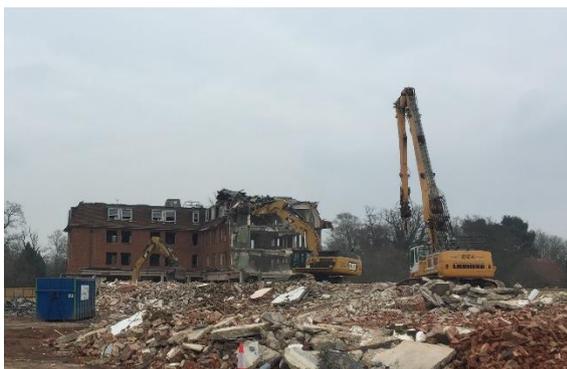
Utilising a High Reach 360° Tracked Excavator with a hydraulic pulveriser attachment rather than a percussive attachment in order to reduce noise and dust emissions, deconstruction of the Sergeants' Mess main building began, The methodology dictated that a top down process was used, removing timber, steel, concrete roof structures for processing and recycling.

The 360-degree high reach excavator with demolition attachment also commenced deconstruction on the centre of the structure and continued progressively through it. The demolition was carried out in accordance with the NFDC High Reach Guidance bay by bay system, in a methodical manner ensuring the building was stepped back.

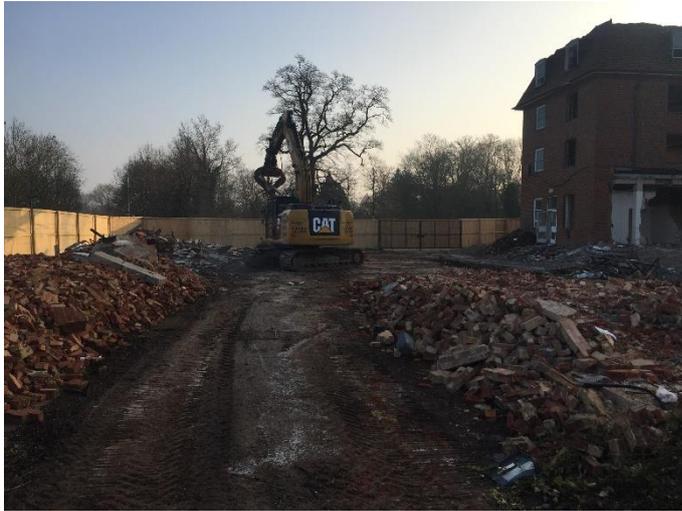
Floors were progressively cleared to prevent overloading and the structural integrity of the building was maintained at all times. Work progressed into the structure breaking

down the individual concrete slabs. The cross beams were then removed followed by support pillars. Next, the brick and concrete walls were broken out and allowed to carefully drop onto the lower floors within the footprint of the building.

Arising's generated from the demolition were utilised to form a ramp for the excavators to use as a work platform during the demolition of the plant room and remaining high level lift motor rooms and stairwells.

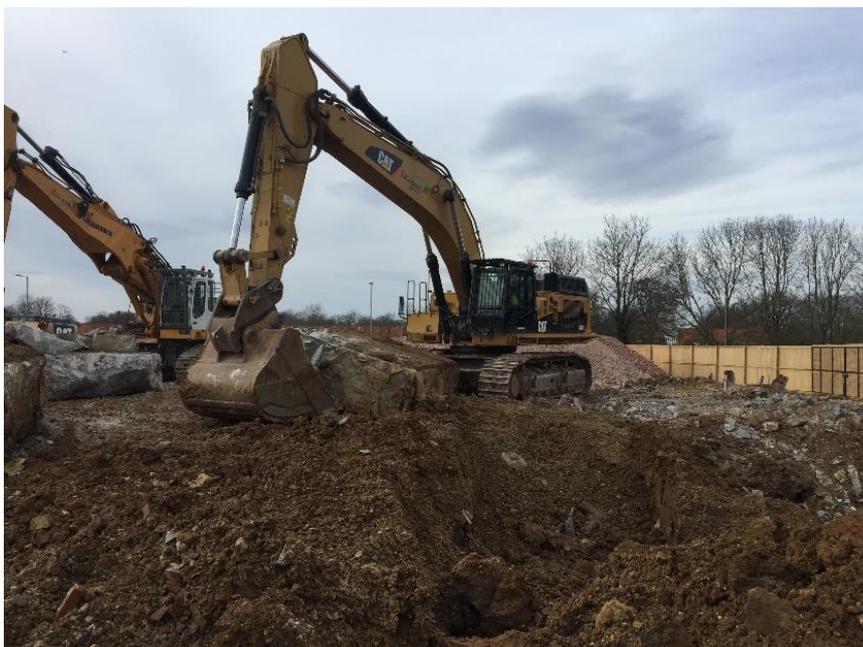
All steel elements of the building were mechanically cut with a hydraulic shear attachment and lowered to ground floor level in a controlled manner.

A second 360° Tracked Excavator, with hydraulic shear attachment, processed the steel and placed it into segregated stockpiles in preparation for loading into the appropriate 40-yard waste bins for management. This was in accordance with the Site Waste Management Plan. Ground floor slabs, foundations, pile caps and hard standings were excavated and removed to a depth of 1.5m.

Water sprays were utilised within the demolition zone to suppress dust during the deconstruction works.

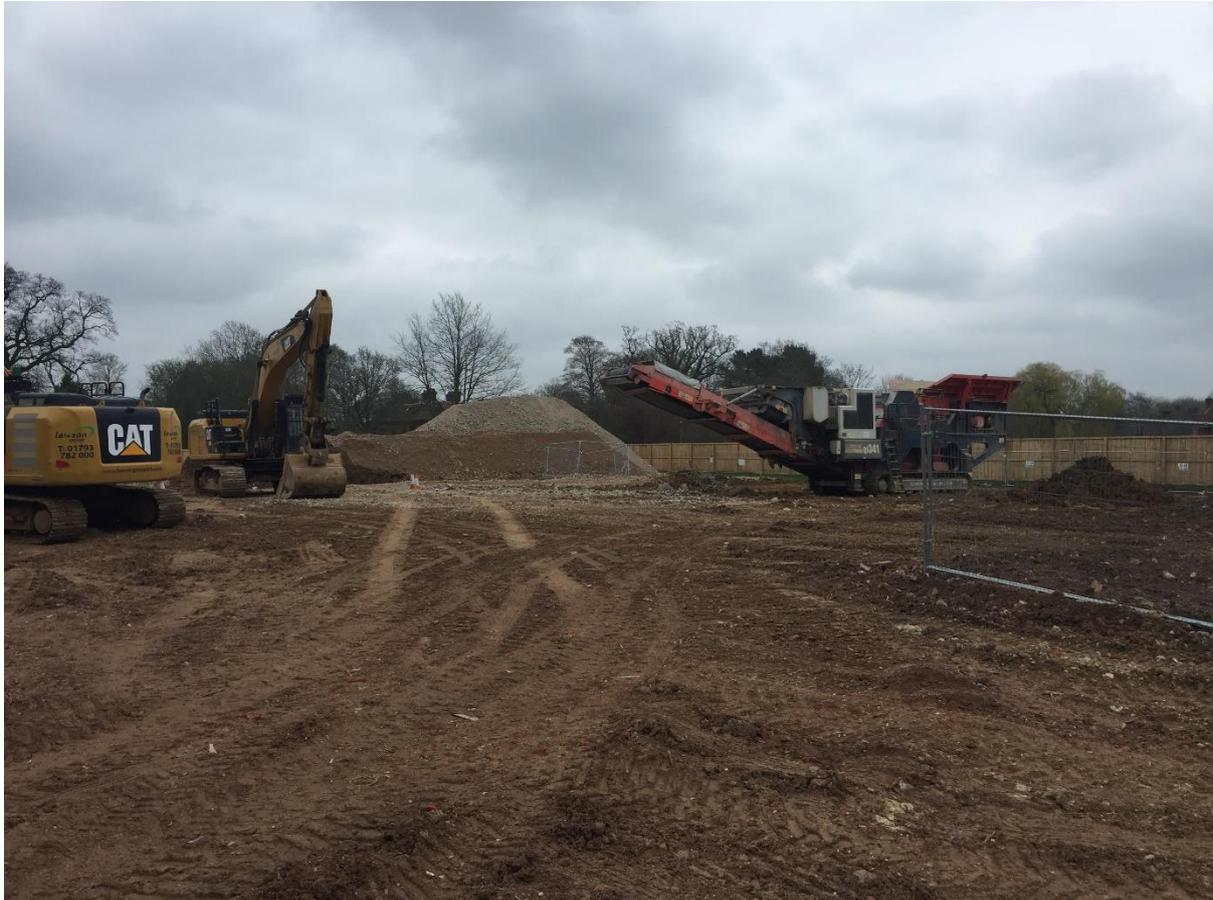
RESULT: All concrete hard standings were removed, and all concrete arising's crushed to a 6f2 specification, material permitting. Brick was crushed to a 60mm down crusher run and stockpiled on site. The site was successfully and safely deconstructed ready for the next phase of redevelopment.
