**CASE STUDY**

**Works:** Deconstruction, Crane Work

## Arborfield Garrison (Metal Footbridge and Footings Removal), Berkshire

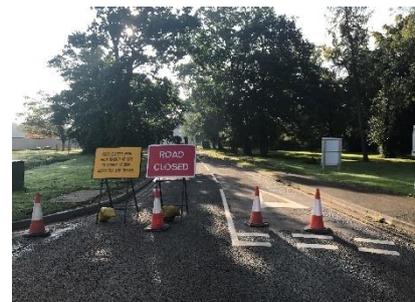
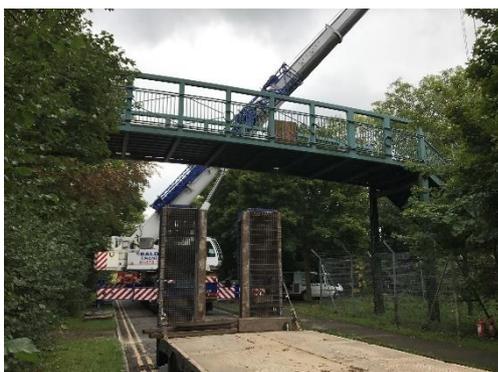
Lawson Demolition operatives gained access to the bridge and marked up the lifting points set out by the contract lift designer. The crane was then brought onto site and set up - all parties involved signed up to the lifting plan. This operation was based on a contract lift, so all plans, drivers, slingers and signallers were brought to site by the crane company and had the correct tickets to operate.

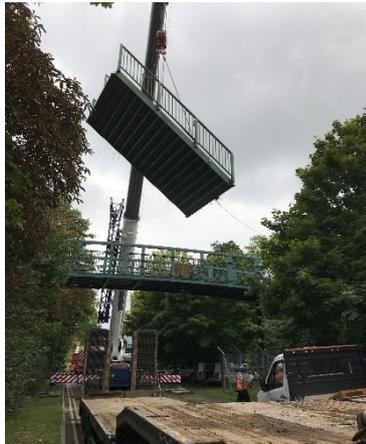
Lawson Demolition operatives then clipped onto a secure structural member using a harness at all times during this working at height stage. Once set up, the chains were checked and were

attached to the landing on the stairs. This was done by cutting a hole in the plate and cutting off the bolts.

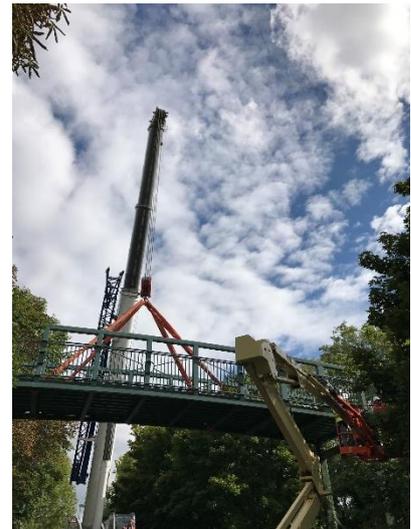
The crane was then attached to the main sections of the footbridge using four legged chains, (as per the lifting plan procedures). Once both landings and steps had been removed from both sides of the bridge, the main bolts holding the footbridge were cut by a trained burner, ready to be lifted. An operative used a cherry picker working from the sides of the bridge, the bolts were removed, either by undoing the bolts or cut using the burning equipment. The bolts were only cut safely from the side of the bridge and never from underneath.

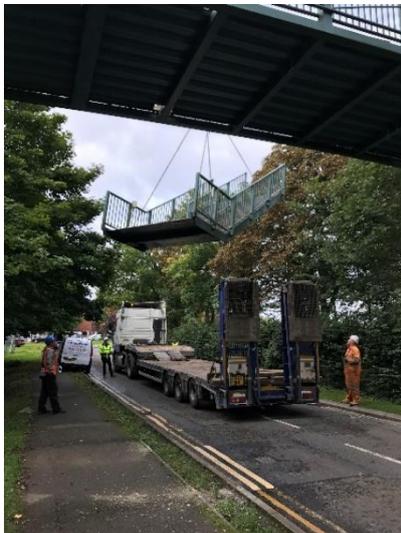
As the final bolts were being cut, the slinger was in contact with the crane operator making him aware of what was happening, and the full control of the bridge was under his command. A tag line was secured to the bridge and used to help control the swing and direction of the bridge. The crane then slowly lifted the bridge which was then lifted up and away from the crane.

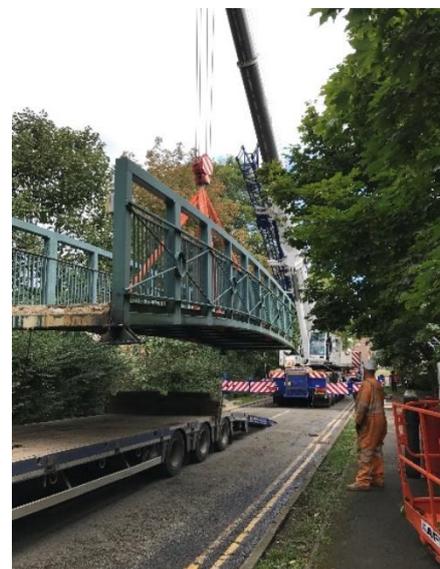
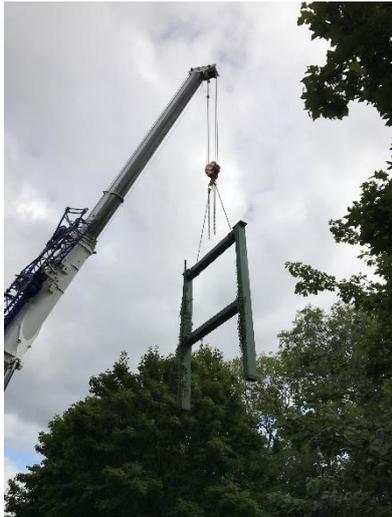
Using the tag line, the bridge was turned ninety degrees and lowered down onto the waiting lorry. Once the bridge section had been placed on the trailer, the load was made secure and then transported around to another area within the Arborfield site. The chains were left on the bridge so it could be lifted off the lorry.

At this separate location, Lawson Group's own CAT 374 with a D Lock was connected to the chains. The machine then lifted the bridge up from the trailer, the truck drove forward leaving the bridge hanging on the chains. The machine then lowered the bridge onto the ground and the chains were removed.

The bridge was then cut up under a separate method statement using machine shears and a breaker.

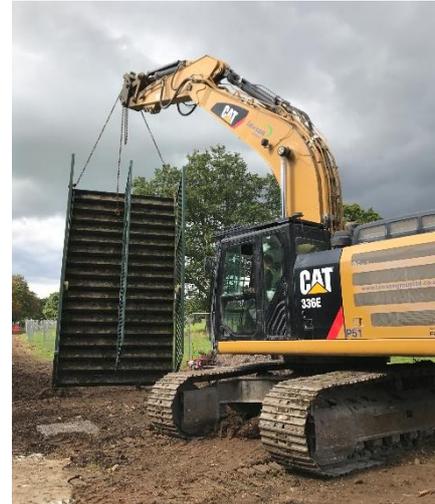
Next, the bridge's footings on each side of the road were dug up and removed, this was done during the week after the bridge removal. Heras fencing had been placed around the work area and a CAT scans were used to check over the area and to ensure that it was free of all services.

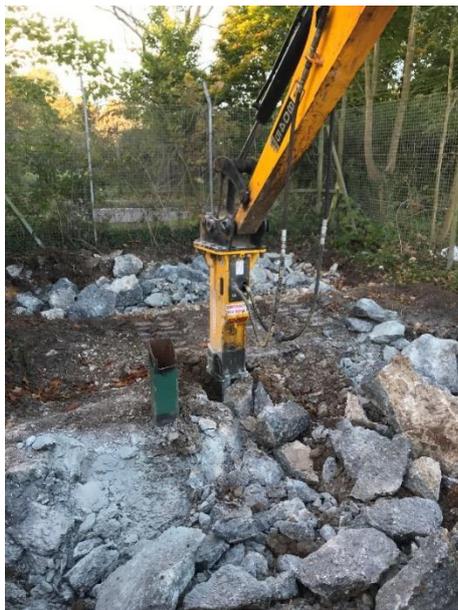
Once deemed safe to do so, the excavator lifted all the concrete out of the ground. For footings that were too large to lift out, a breaker attachment was placed on the machine to break up the concrete first.

The concrete was removed by loading into a tipper or road legal dumpers and tipped onto the Arborfield site ready to be crushed. The crushed material was then brought back to the former bridge site and recycled to fill in the excavated hole.
