Arborfield Garrison (Demolition of Rowcroft Barracks), Berkshire

Phase 2: The demolition of Rowcroft Barracks School Site

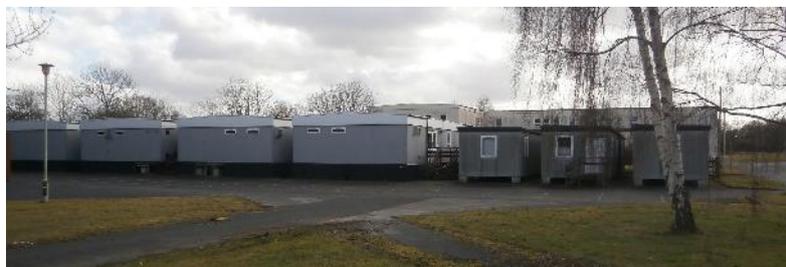
Buildings 8a

These buildings were based to the north of the site and were demolished using a smaller machine which took to the porta-cabin after they were soft stripped.

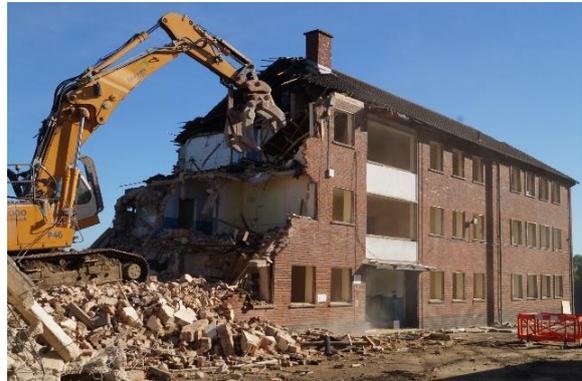
Building 62 was one of the larger buildings on site which was to be demolished. It required one of Lawson Demolition's larger machines, the CAT 944, which demolished the building in its entirety in 3 days. An experienced demolition operative undertook the task of demolishing the building which required a methodology of demolition using a fixed grab attachment to demolish the brick building.

A CAT 323 worked through the demolition arisings to process the materials ensuring that Lawson Group's recycling targets were met. Building 62 was predominantly made out of brick and concrete which was able to be crushed on site with some of the material being recycled as a subbase for the roads.

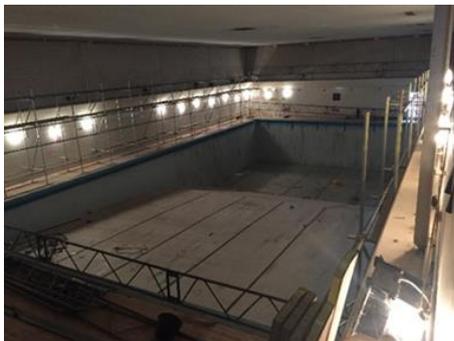
Building 10 Swimming Pool and Sports Hall.

The scope of works for the swimming pool and sports hall required extensive licensed asbestos removal to the boiler rooms, treatment and basement plant rooms, ceiling throughout the swimming pool, squash and sports hall.

All treatment plant and pumps were fully decommissioned, and all tanks were pumped and emptied. A full scaffold platform was erected over the swimming pool to form a working area and allow

for a full asbestos removal enclosure to safely remove all ceiling panels. Once all hazardous material had been removed mechanical demolition to the super structures was completed.

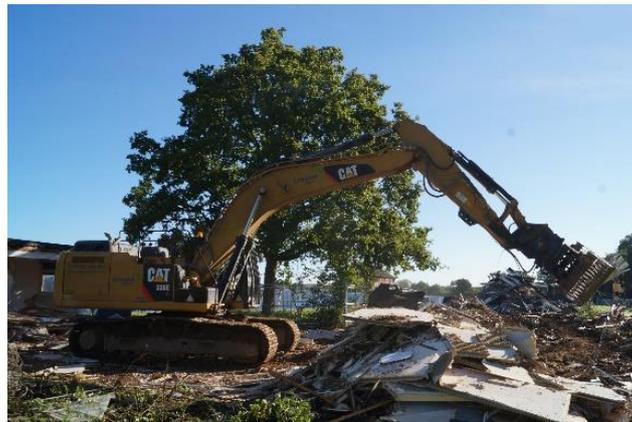
Building 41 - A sheer attachment on the CAT 336 was used for sorting the demolition arisings from the demolished building, as shown below.

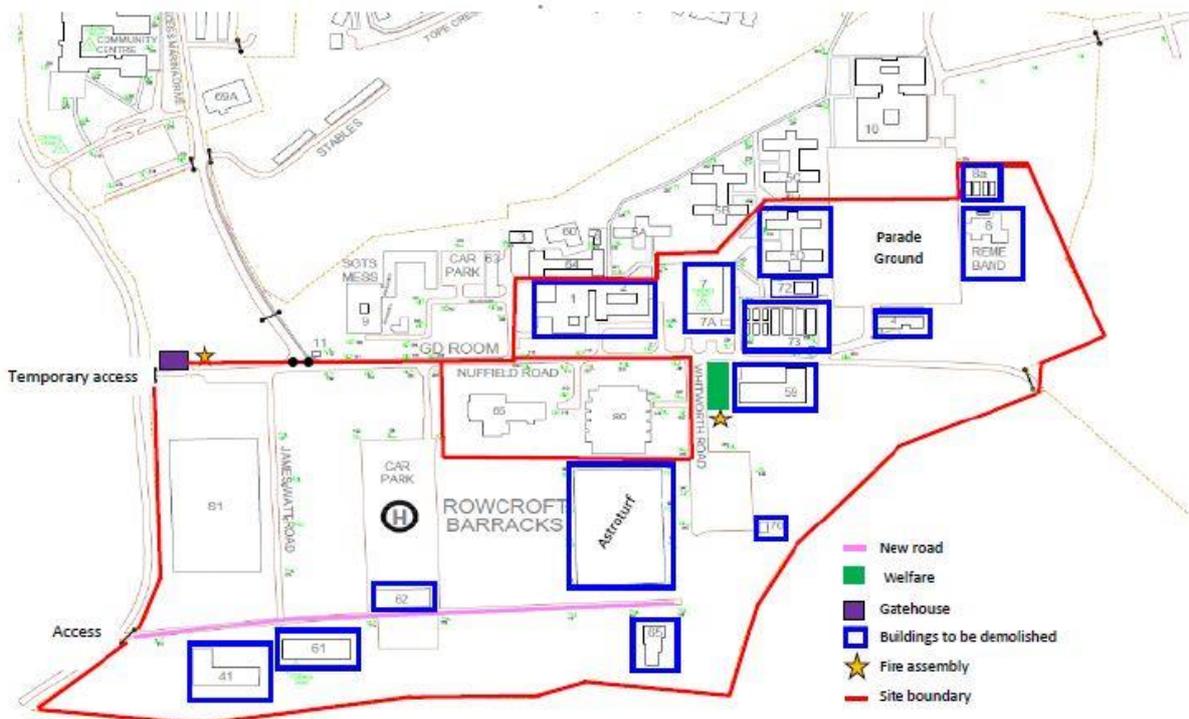
RESULT: Once all the buildings marked on the diagram below were successfully removed, the site was handed over to the client for the next stage of development.
