## Arborfield Garrison (Parcel X and Y Demolition), Berkshire

**OVERVIEW:** As part of a demolition programme of the entire Arborfield Garrison site, Lawson Group were asked to demolish buildings that formed an area known as Parcel X and Y.

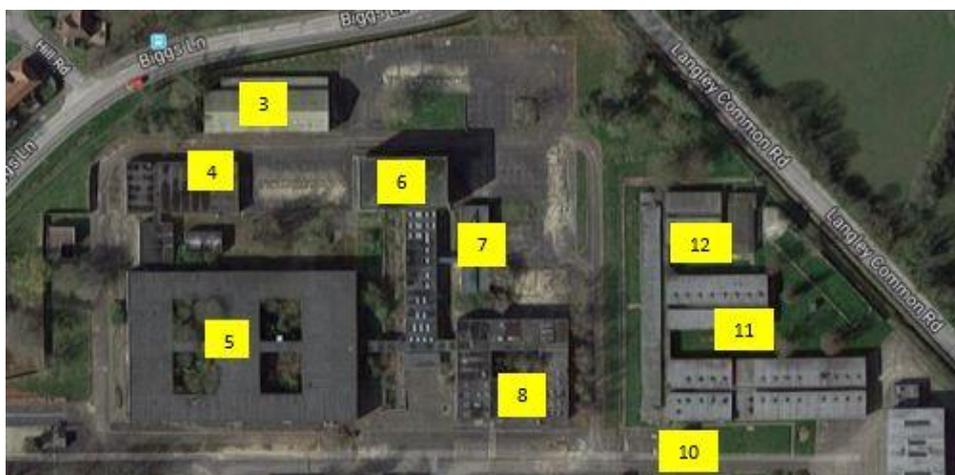
**SOLUTION:** Any Asbestos containing materials were systematically removed from the buildings as per the scope of works produced by Lawson Environmental. The order of asbestos removal followed the order of Buildings 12, 11, 10, 07, 08, 06, 05, 04, 03

(shown in image below) with soft stripping and then demolition using the same order for processing after each building was clear of asbestos. Once the soft stripping had taken place then the demolition phase could begin.

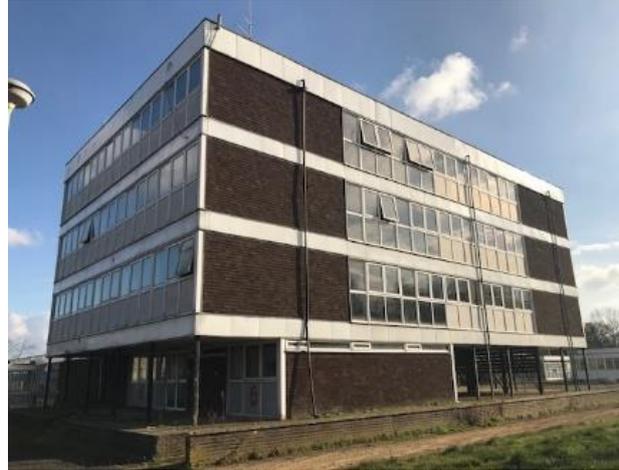
### **Building 6**

This was the tallest building on the site. When soft stripping this building, all floors were stripped as per the agreed methodology, with material being dropped in a designated and fenced off drop zone around the building

This designated drop zone formed around the building allowed material to be safely dropped from an upper location eliminating the risk of hitting an operative at ground level. Using this method also eliminated the risk of carrying material down the stairs, which in turn eliminated potential trips and falls. Signage around the perimeter was used to clearly show the drop zone. A supervisor constantly monitored the weather in case there was a change in wind speed or direction that could alter the falling material route to ground. All lightweight objects were bagged and then dropped.

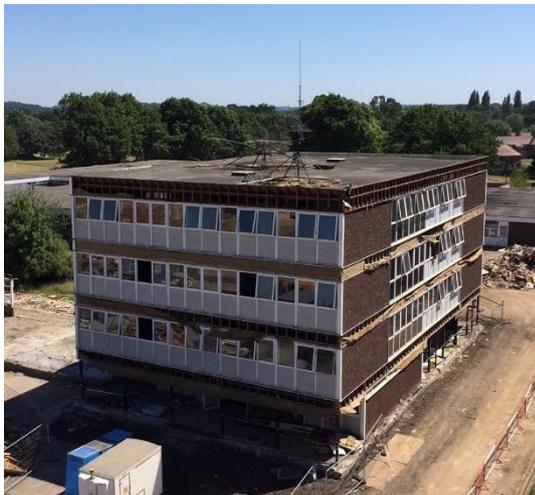
### **Mechanical Deconstruction Building 6**

Following the soft strip, the demolition phase could start. Dust suppression equipment was set up next to the demolition excavator. A water supply from a fire hydrant was used to supply the tank via a licensed standpipe. A 360-demolition excavator, with high reach arm and demolition attachment, was positioned at the rear of the structure, all voids in the ground such as manholes and sewers were protected. Using a hydraulic grab attachment, the roof was removed back to the first supporting column allowing one bay of the roof to be lowered carefully to the ground floor slab.

Any wood and timber were then removed and lowered to ground level away from the building. Once the roof had been removed, the internal walls and floors were removed and lowered to ground level. The external walls were left until all internal walls had been removed to help contain any dust generated. The stability of the building was continually monitored by the excavator operator and the demolition supervisor. This process of deconstruction was repeated until the entire building had been removed.

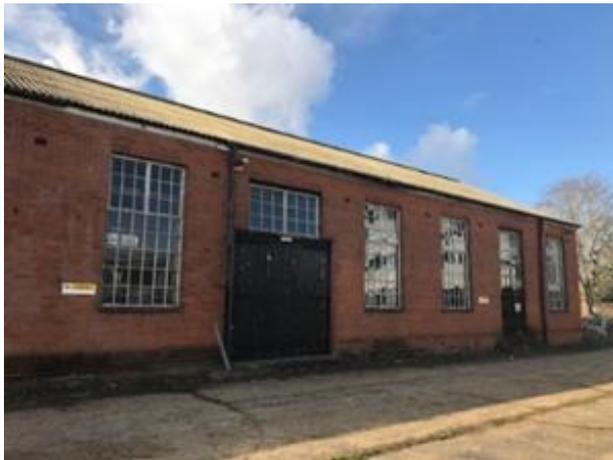
### Building 3

This building had Asbestos roof sheets which had to be removed before the building could be stripped and demolished.

Only operatives who had received Class 2 Asbestos training undertook this work. The area was cordoned off with tape and signs displayed. An asbestos zone for the removal of the roof sheets was formed using tape and asbestos warning signs. The site was segregated to stop anyone not involved in the work from

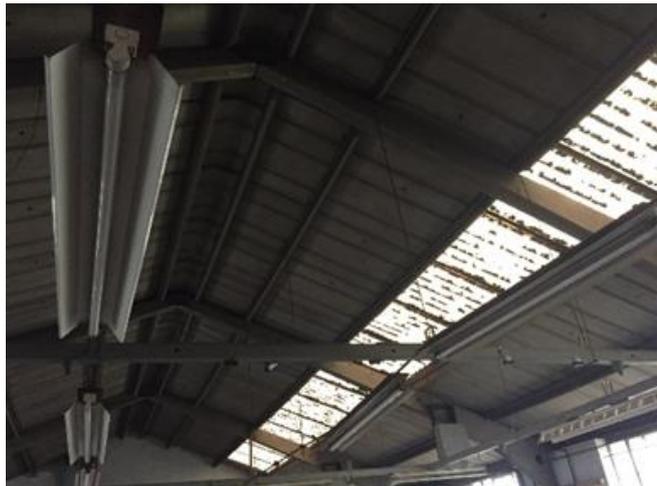
A respirator only exclusion zone was set up utilising Heras type fencing with warning signage attached to prevent unauthorised access into the working area. To remove the roof sheets, a MEWP scissor lift was used. These MEWPS were positioned in the centre of the building starting at one end. The undersides of the sheets were wetted down before removal using a hose pipe fed from the building's water supply.

An operative supported one end of the first sheet, the second operative using a battery powered reciprocating saw, cut the U-bolts that supported the sheet. Both operatives then lowered the roof sheet down, this was then passed to ground level. The roof sheets were then placed on the pallet forks of the forklift. This process of

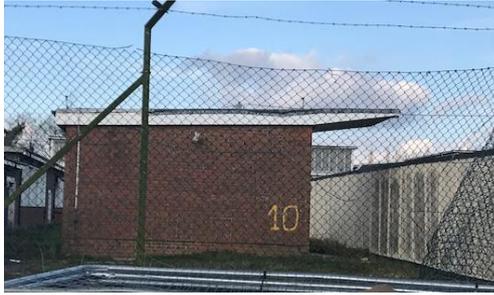
## Building 10

This was a small structure which was demolished using a 360 excavator from the side and working from the top down.

A banksman was used to help guide the machine operator as care needed to be taken so as not to damage timber hoarding located nearby.

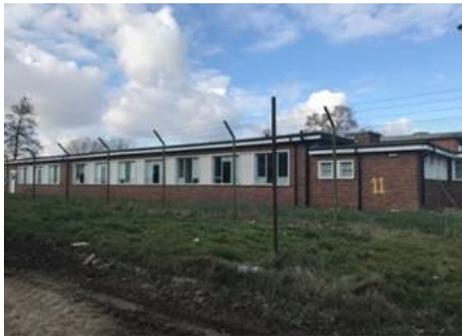
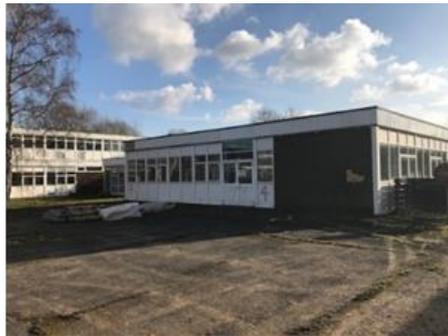
## Buildings 11, 12 and 4

These structures were of brick construction and had flat timber roofs.

The 360-machine with re-handling grabs, removed the roof timber structure first and place into 40-yard bins. The main structures of the buildings were then removed as described in the above demolition process described for building 6.

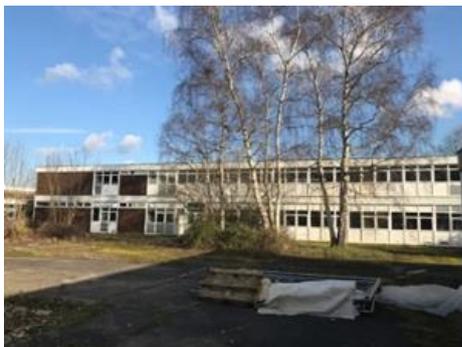
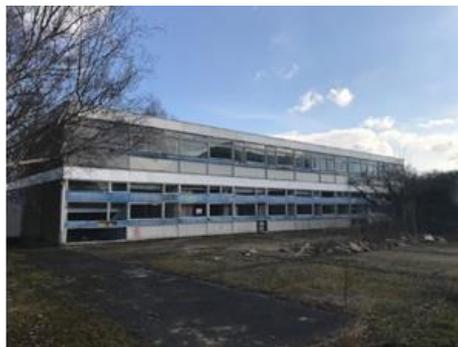
## Buildings 5 and 8

These two buildings were two storey, brick structures with flat timber roofs.

As with the other similar buildings, the roofs were taken off and the timber cladding removed from the walls. This was kept separate before the 360-excavator removed the brick walls. Using re-handling grabs was key to separating the general waste from the recyclable material.

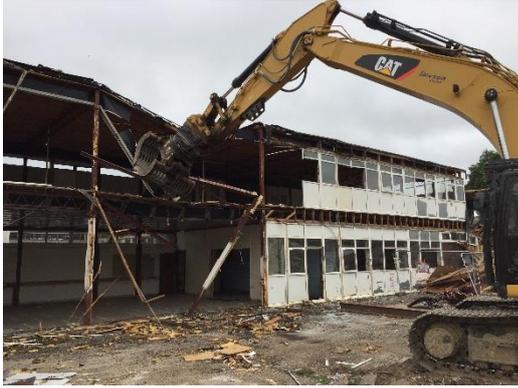
Before slab and foundation removal could occur for **all** buildings, services in the ground would need identifying. Using a service drawing issued by the client, along with a CAT

scanner and Geni, all known and identified services were marked out on the ground using spray paint. All operatives were shown the locations and made aware.

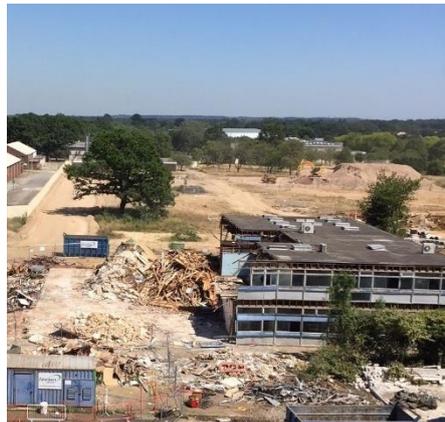
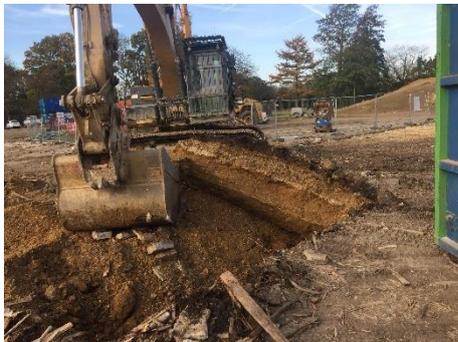
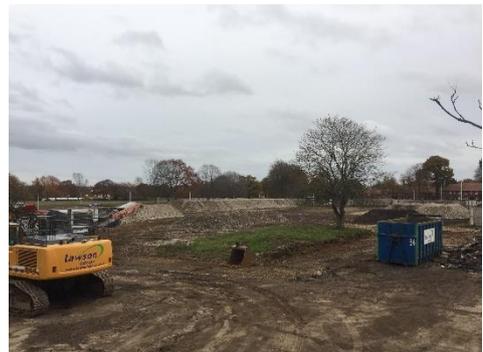
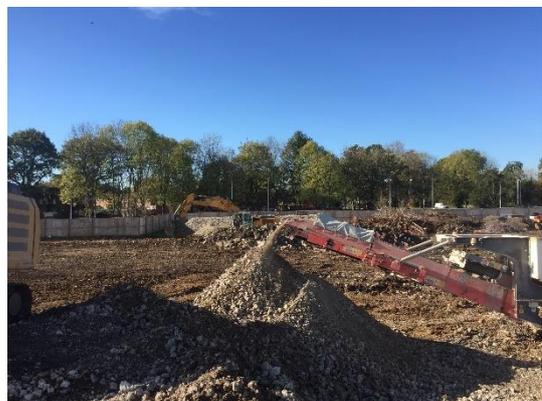
The Mobile Crusher was operated in accordance with the Safe Operating Procedure from the NFDC. Daily Plant Inspections were conducted and recorded on the Plant/Vehicle Checklist. All defects were reported in accordance the Company Defect Reporting Procedure.

positioned next to the stockpile of material on firm level ground. A hearing protection zone was set up around the crusher with signs attached to Heras fencing, this was indicated on the site drawing, included in

The 360-degree excavator loaded the crusher in a controlled manner ensuring material was not over-loaded in the hopper. This was positioned on the stockpile, high enough to allow the operator to monitor the feed into the jaw of the crusher. All arisings from the crusher were stockpiled on site and removed from the crusher belt using an excavator

or loading shovel. The discharged material was allowed to heap up to reduce the height the crushed material could fall; this reduced the dust generated from the discharge belt. The crusher moved along the stockpile as and when required.
