CASE STUDY

Works: Licensed
Asbestos removal

Longcross Studios Building #108, Chertsey

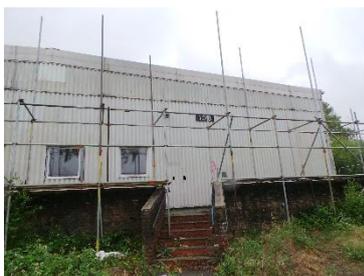
Fixed scaffolding would need to be erected around the perimeter of the building. The scaffolding would need to be outside of the asbestos enclosure and about 1.5 metres away from the building. It would require ranch boards to the building side of the scaffolding to assist with the enclosure construction.

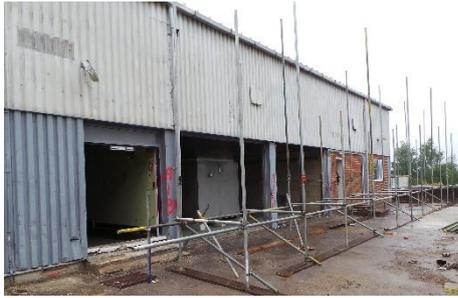
The scaffolding would need to be screened with Monarflex sheeting and required one boarded lift and a loading bay to the back of the building. This would enable the Negative Pressure Units (NPU's) to be positioned on the scaffolding.

Negative pressure units (NPU's), giving a minimum effect of ten changes per hour, were attached to the opposite end of the enclosures from the entry and exit point. These were located on the first lift of the fixed scaffolding. The size of the NPU's depended on various inputs and this was noted in volume of enclosures where applicable. The NPU's were designed to vent to an external atmosphere.

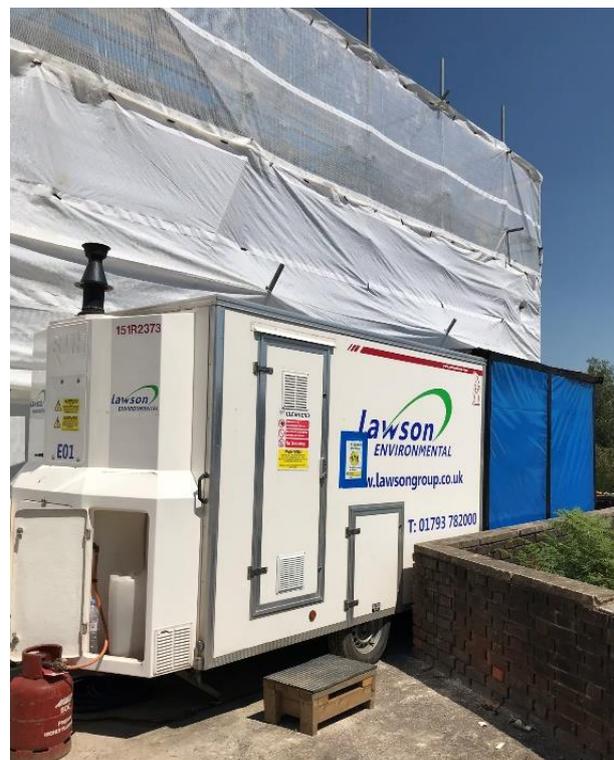
Photo 1	Description: Airlock & baglock fixed to scaffolding	Photo 2	Description: 10 x 4000 NPU on 1 st lift of scaffolding at the rear of the building.	Photo 3	Description: Access side of the building with scaffolding over the wall to the wall.	Photo 4	Description: Rear of building NPU location scaffolding and loading bay	Photo 5	Description: AIB to beam within building

A baglock, for bag transfer, was incorporated onto the enclosure for the safe transfer of waste. This baglock was incorporated on the

external part of the enclosure. The third compartment of the bag lock included cleaning facilities for decontamination and cleaning waste bags before double-bagging.

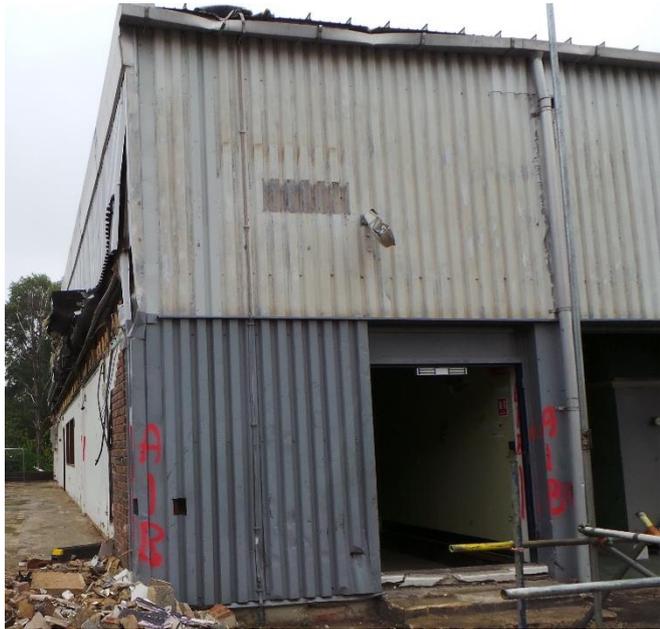
Photo 6	Description: AIB behind metal wall cladding within the building	Photo 7	Description: AIB panel to beam	Photo 8	Description: AIB to beam behind tin cladding	Photo 9	Description: AIB to beam behind tin cladding	Photo 10	Description: AIB to beam behind tin cladding

The external AIB to the beams were located behind tin cladding, this was removed only where needed to provide access to the AIB panels. The cladding was removed using hand tools to split the cladding along the seam. If this was not possible, then a reciprocating saw was used.

Once the tin cladding had been released, a Lawson Environmental operative applied an application of fibre suppression to the back of the tin columns and AIB. The cladding was carefully lowered to the ground and placed on a prepared polythene sheet. This polythene sheet was used to wrap the panels. As before, these wraps were cleaned and left within the enclosure and removed after the air test.
