**CASE STUDY**

Works: Demolition

## Longcross Studios Building #99 Tower, Chertsey

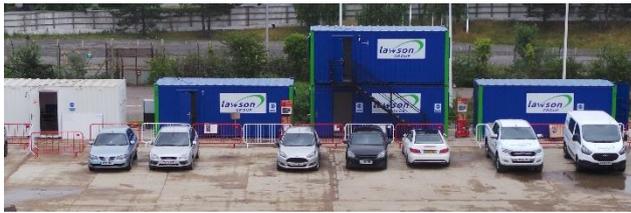
Site welfare and parking were located on the concrete slab at the front of the site. Heras fencing was supplied by Lawson Group with debris netting attached and was positioned around the boundary of the site. For safety and security, the access gate

always remained closed and locked. The contact phone numbers for site supervisors and managers were displayed for site access.

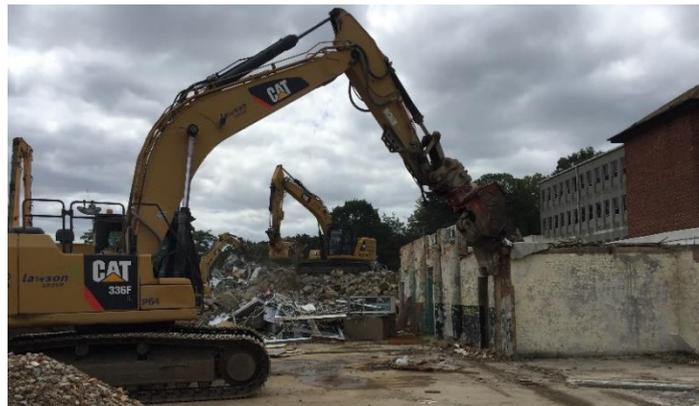
Building #99 Tower was previously used as a telephone exchange and was built out of brick and timber with a tiled roof. It was sited next to building #114. The lower part of the structure was constructed of a mixture of concrete and brickwork walls.

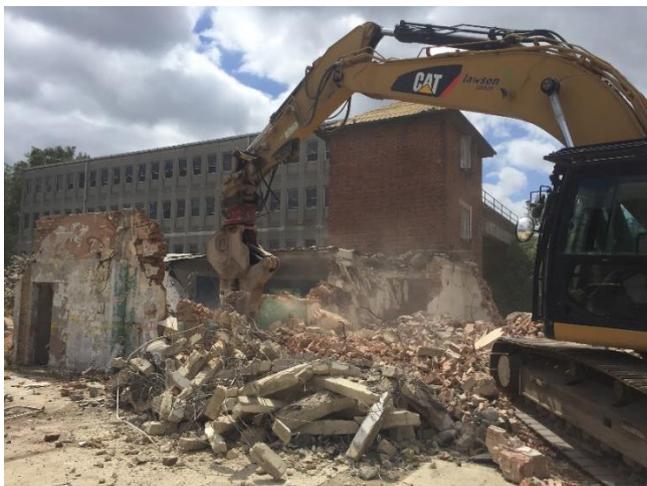
Internally, this building was a challenge. Soft stripping was needed, and tiles needed to be removed for a bat check before any works could commence - but no bats were found in this building. A CAT scan of the site was carried out by the demolition supervisor who had received the relevant cable detection training.

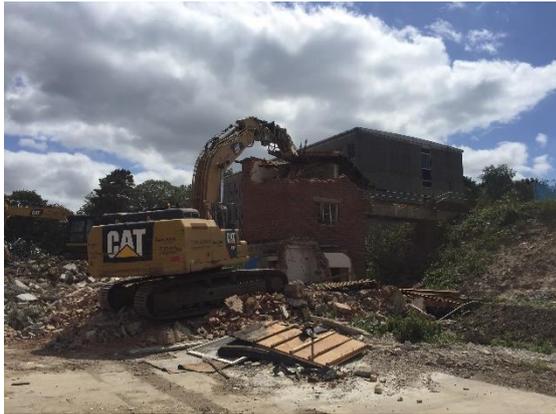
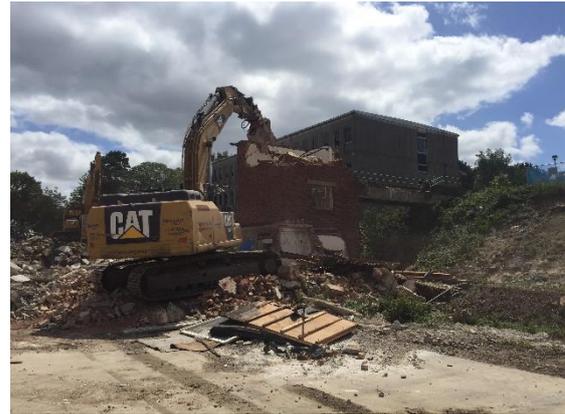
After completion of the soft strip, demolition could commence. This started on the structure located at the lower level. A Lawson Group owned CAT 336F excavator, fitted with a hydraulic grab attachment, was used to dismantle the concrete and brickwork structure. Starting from the east-facing side of the structure, the walls were carefully removed, leaving the brick-built tower structure.

Next, the wooden and tiled roof of the tower structure was removed, followed by stepping down of the structure's four

walls. This process was repeated until the entire building had been deconstructed. The concrete and brick access bridge was also removed. The wood, brick, concrete and other associated materials were removed and lowered to ground level away from the building. These were processed in accordance with the method statement devised by Lawson Group's highly qualified project management team.
