CASE STUDY

Works: Licensed asbestos removal, soft strip, demolition

NHS Centre - Kimmerfields, Swindon

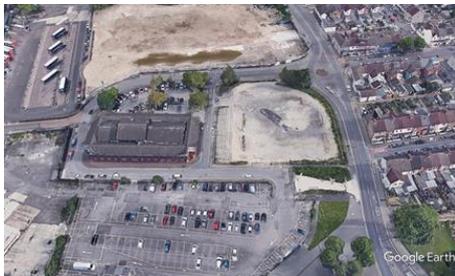
The building was two storeys high and of brick and block wall construction, under a timber and tiled roof. AIB wall and ceiling

panels were present in several rooms and the decorative external

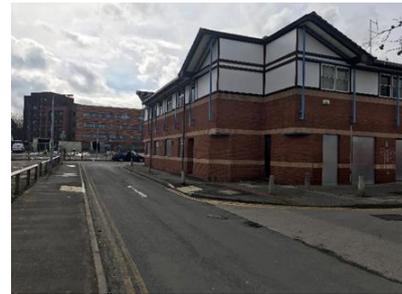
white panels were made up of asbestos cement sheeting. A live substation was located within the site, which was planned for reuse, so the works included its protection. Service access to the Zurich Tri-Centre office was required through the site perimeter. This redundant building had been used for emergency temporary homeless accommodation over a cold period. A full needle sweep of the building was required before works could commence.

Lawson Environmental carried out the asbestos removal works under controlled licensed conditions. The AIB panels were removed in sealed negative air pressure enclosures. The external cement bonded asbestos (CBA) sheets were removed by hand, utilising a MEWP under Notifiable Non-Licensed Works (NNLW).

All sheets were first dampened using a suppressant mix, the bolts were cut, and sheets were lowered one by one. They were then removed using a skid steer and placed in a stacked pile in an enclosed 40-yard skip. During the CBA removal, independent background and personal air monitoring was carried out. Once the asbestos had been removed and the area had been cleared, demolition work could begin.

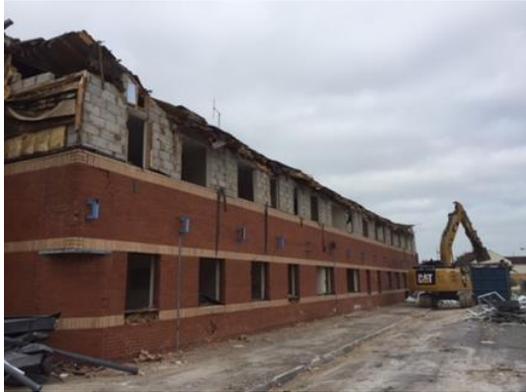
A 360-excavator was used with a hydraulic shear attachment. The roof was removed back to the first supporting column allowing one bay of the roof to be lowered carefully to the 2nd floor slab.

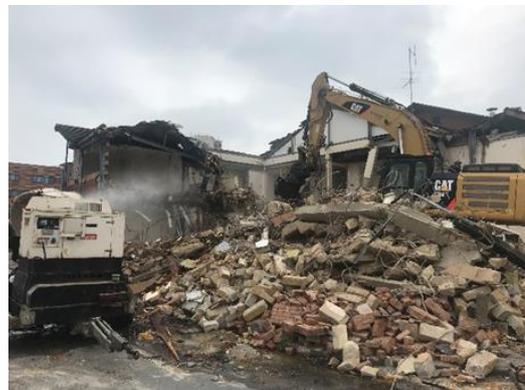
Once the roof had been removed, the internal walls and floors were dismantled and lowered to ground level. The external walls were left until all internal walls had been removed to help contain any dust generated. A dust boss was also used for dust suppression.

This sequence continued until the building was demolished. All waste was separated during the demolition, ready for disposal at registered recycling facilities. The concrete and bricks were retained on site and crushed using Lawson Group's own mobile crushing equipment.
