## CASE STUDY

**Works:** Licensed Asbestos Removal

# Arborfield Garrison (Hazebrouck Barracks Asbestos Removal), Berkshire

**OVERVIEW:** As part of the prestigious project at Arborfield in Berkshire, Hazebrouck Barracks needed licensed asbestos to be removed from five of its buildings. Lawson Environmental (part of Lawson Group) were utilised to carry out this specialist work.

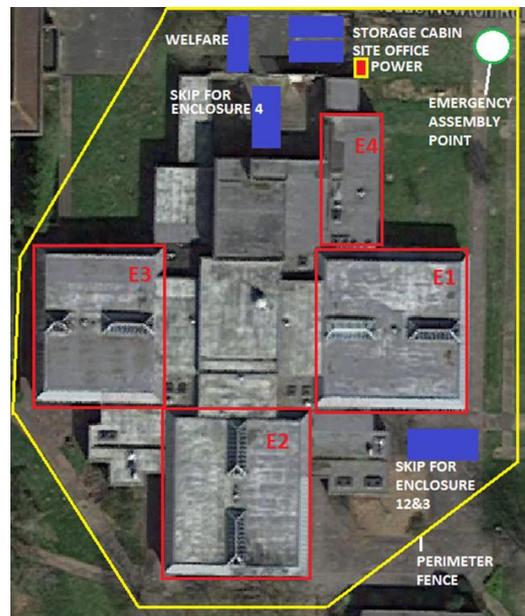
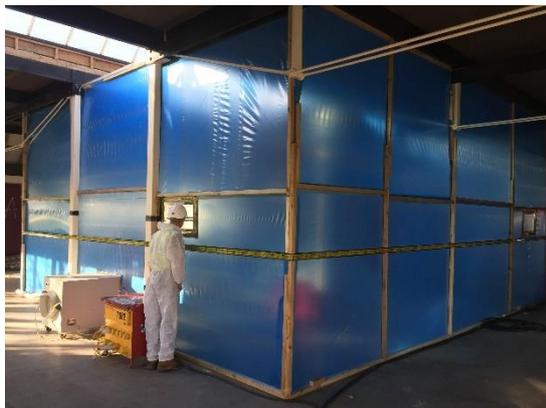
The enclosures were formed using existing structural elements of the building and timber framework to which 1000-gauge polythene was fixed. Staples were used to secure polythene sheeting to the timber framework. 75mm polycloth tape and spray adhesive was used on all joints and areas that needed to be sealed. The floor of the enclosure was formed again with 1000-gauge polythene and any joints closed with 75mm tape. A sacrificial sheet of polythene was then used whilst

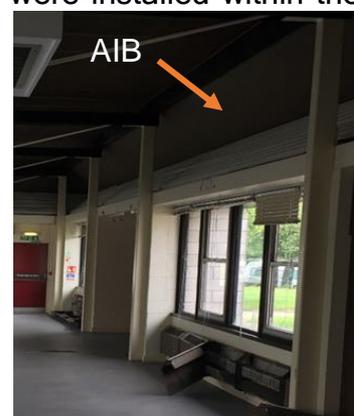
To remove the high up, sloped insulating panels, operatives accessed the area of work via a scissor lift with an extending platform. Once the basket was at the correct height, the operator pushed the extending platform out towards the sloped insulating panels, the operative then assessed the safest method and commenced their removal. The AIB sloping panels were screwed and nailed onto the wall, these were removed using hand tools and cordless drills. The fixings were removed in conjunction with using shadow vacuum procedures (LEV).

After the first panel had been removed the void was vacuumed as far as could be reached without over-extending, then a water and surfactant mix was applied using a handheld manual pump-up spray to the rear face of the next panel and left to penetrate.

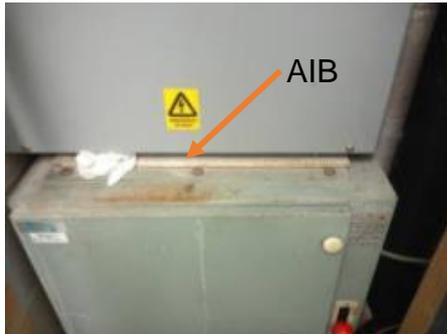
Insulation board was found between two electrical boxes, so were fully wrapped in 1000-gauge polythene. A sheet of 1000-gauge polythene was then laid on the floor below each box. Each of the electrical boxes were then removed from the wall using small hand tools and lowered carefully to the floor.

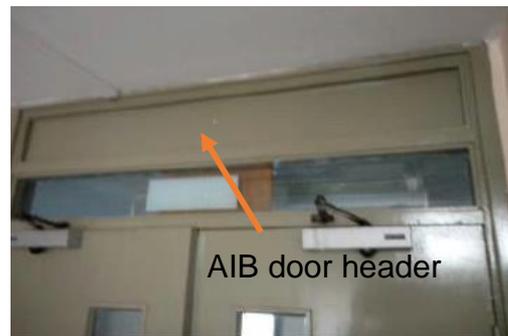
**Building 54:** This building, with enclosures and DCU, was set up in a similar way to that of building 44 above. Door header panels on the first and second floor corridors were then removed. Some of the AIB had been screwed and these were all visible. They were removed using hand tools and cordless drills. Other AIB had been nailed on, these were also removed using hand tools. The fixings were removed in conjunction with using shadow vacuum procedures (LEV).

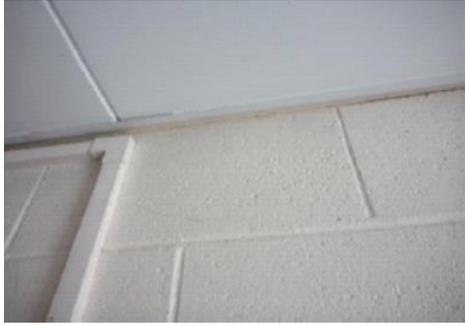
**Buildings 70, 71 & 72:** Again using the same preparation of the building as Building 44, work started on Buildings 70, 71 and 72 to remove the contaminated non-asbestos ceiling tiles and AIB edging strips. The ceiling tiles had also been screwed in but not all screws were visible. These were removed using hand tools and cordless drills. The fixings were removed in conjunction with using shadow vacuum procedures (LEV). The tiles around the perimeter of the ceiling were removed first and the void was inspected for any apertures to adjoining areas and were sealed as necessary. Once the perimeter tiles had been removed, the remaining tiles were removed in a sequential manner.

Once the first of the remaining ceiling tiles had been released, an operative lowered one side in order to make the back of the ceiling tile accessible for decontamination. The back of the tile was carefully vacuumed, prior to carefully applying an application of fibre suppression and then lowered horizontally. The ceiling tiles were then placed into red bags, sealed and put neatly to one side until ready to be removed from the enclosure.

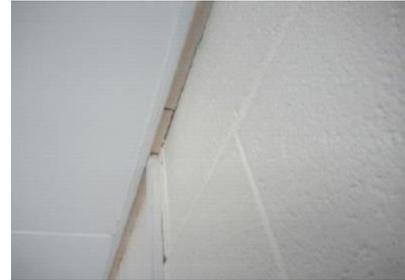
Any MMMF insulation in the ceiling void above was sprayed with surfactant and double bagged for disposal as contaminated waste. Once all ceiling tiles had been removed, the AIB infill strips were sprayed with surfactant and left to soak. Once they had sufficiently soaked, they were removed using shadow vacuum techniques and placed into red bags ready for disposal.
