CASE STUDY

Works: Licensed Asbestos Removal and Remediation

Arborfield Garrison (Rowcroft Barracks Licensed Asbestos Removal), Berkshire

Rowcroft Barracks (including Sergeants Mess) Licensed Asbestos Removal

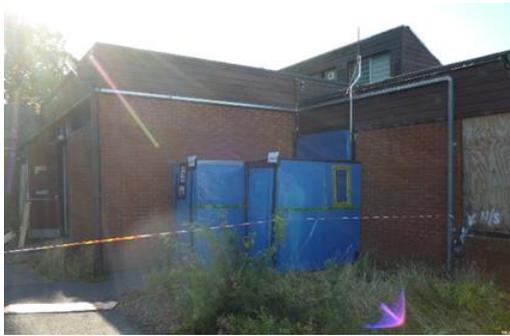
The enclosure to remove the AIB shuttering in Building 8 can be seen below.

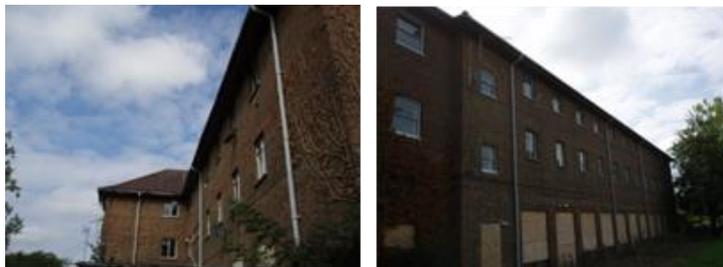
External AIB soffits at Sergeants Mess can be seen in the two images immediately below.

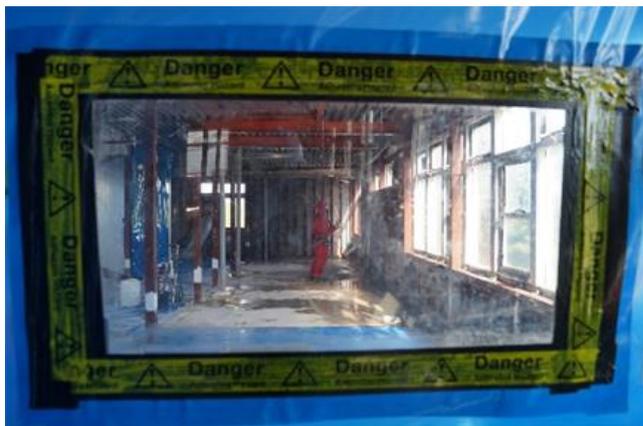
Once the first AIB panel was released, one operative lowered the panel in order to make the back of the panel accessible for decontamination. The back of the panels were carefully vacuumed prior to carefully applying an application of fibre suppression. The panels were then lowered horizontally onto a prepared polythene sheet. Next, the

panels were wrapped in the polythene sheets with smaller panels bagged into red bags which were sealed and placed to one side until they were ready to be removed from the enclosure.

An enclosure was formed using existing structural elements of the building and timber framework to which 1000-gauge polythene was fixed. Once the enclosure, airlocks and bag locks were constructed, Lawson Environmental's qualified operatives used hand tools and cordless drills to remove the screws and nails which were visible as they were used to fix the AIB to the ceiling. The nails were removed in conjunction with the shadow vacuum procedures (LEV).

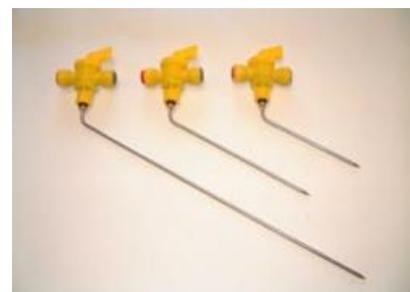
Where a section of lagging was removed to allow the pipe to be cut, these sections were injected using an injection system (examples on right) before being removed with hand tools.
