CASE STUDY

Works: Demolition with planned road closure

Demolition of footbridges associated to Multi-Storey Car Parks, Swindon

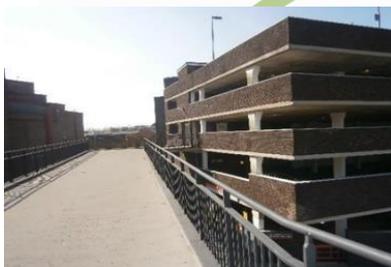
Bridge no.1

The demolition of this footbridge would require a managed closure to be implemented which would require the creation a temporary closure to Islington Street and would enable the shops behind the site to still be accessible whilst allowing vehicles to still pass through. The public footpath and the disabled access to the Wyvern Theatre would have to remain open throughout the works and an area of the flat car park would also have to be open for customers of the theatre.

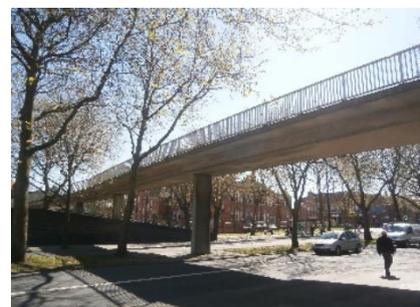
Bridge no.2

Road closure, traffic diversion, protection of road, footpath and surrounding trees would be required for this bridge. Site security would be paramount to this element of the project located in a busy town centre and close to a popular and busy bars and restaurants complex; there was heavy pedestrian and vehicle traffic in close proximity.

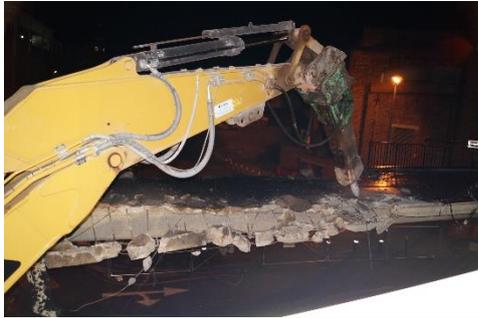
Removal of footbridge No.1

A gateman and the site manager communicated and if a vehicle wished to pass, work stopped to allow them to go through to the destination of choice. Due to the location of the site, in agreement with the client, the work was required to be undertaken on a Saturday

night. Lawson Group's specialist demolition operatives started work at six o'clock in the evening and cleared the site by four o'clock on the Sunday afternoon when the managed closure to Islington Street ended. Communication was continuous between Lawson Group and the client and the Wyvern Theatre throughout this period to ensure that minimal disruption was maintained throughout the works.

The scope of work was completed utilising two of Lawson Group's company owned demolition excavators: the Liebherr 944 and CAT 336. The two excavators were continuously in use utilising a multi-processor and MP30 and MP20 breaker attachments to crush the concrete. A drop zone was created underneath the bridge in addition to an exclusion zone which prevented unauthorised persons from entering the demolition zone.

The demolition machine operatives started the demolition in the middle of the bridge, working their way out towards the entrances of the footbridge.

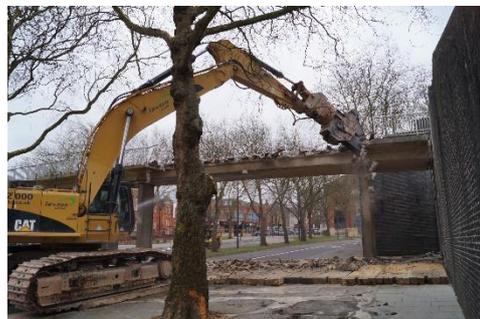
Removal of footbridge No.2

For the demolition of the footbridge spanning a four-lane dual carriage way, works were completed over a continual 24hr shift period, 12 hours ahead of programme. Road closure, traffic diversion, protection of road, footpath and surrounding trees were required. Traffic management with a full road closure and diversion of dual carriage way was implemented.

Lawson Group had been granted possession of the dual carriageway by the Highways Agency for a 36-hour period. The road required complete protection to ensure it was safe and in the same condition to reopen following the bridge demolition. The roads were protected using bog mats with all plant working from within protected laid areas.

All concrete and steel waste was removed directly from the site. As the bridge was progressively demolished, waggons were on hand waiting to transport all demolition arisings to Lawson Group's waste recycling centre.
